The Restoration of Ensign #114 Windcaller

Background

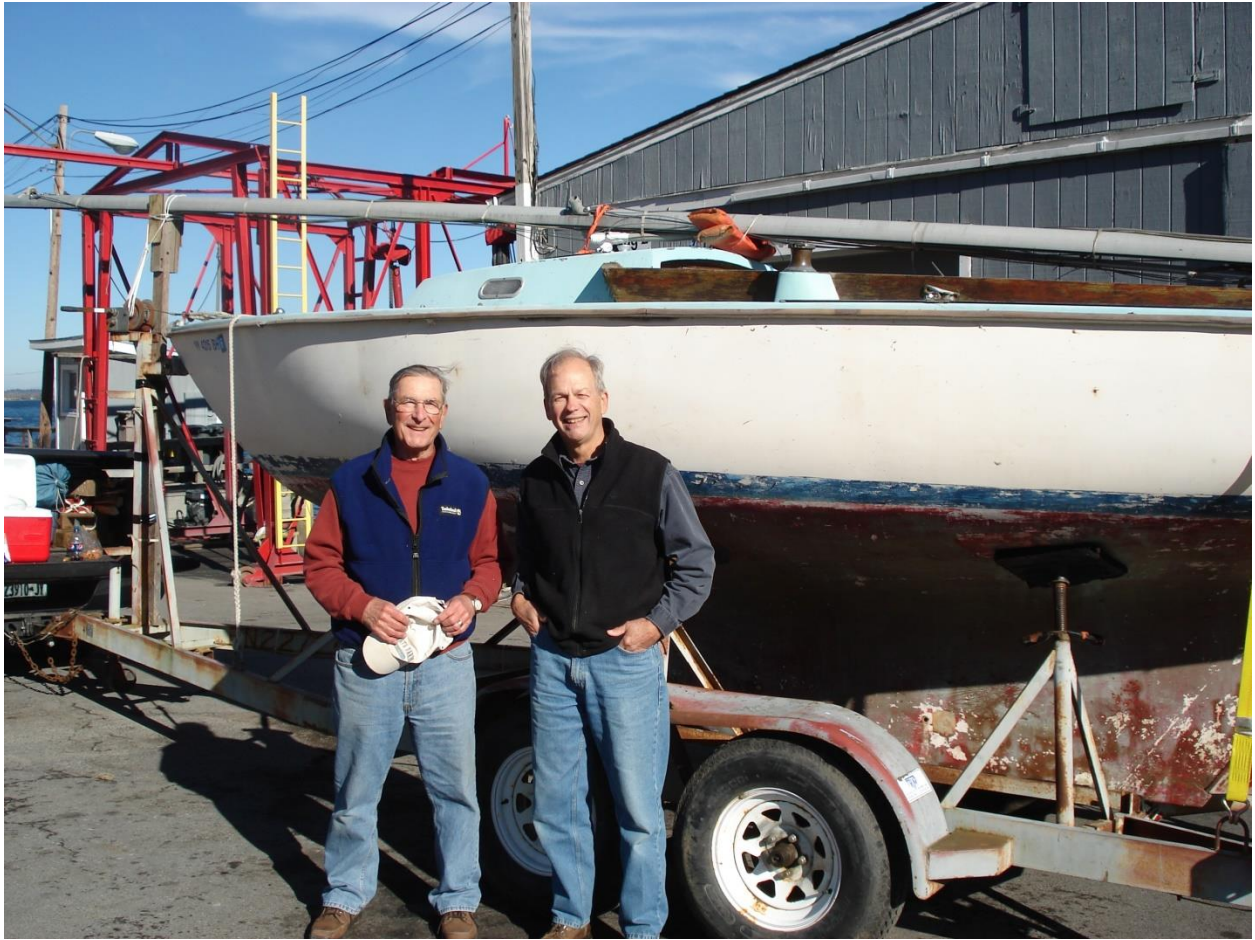
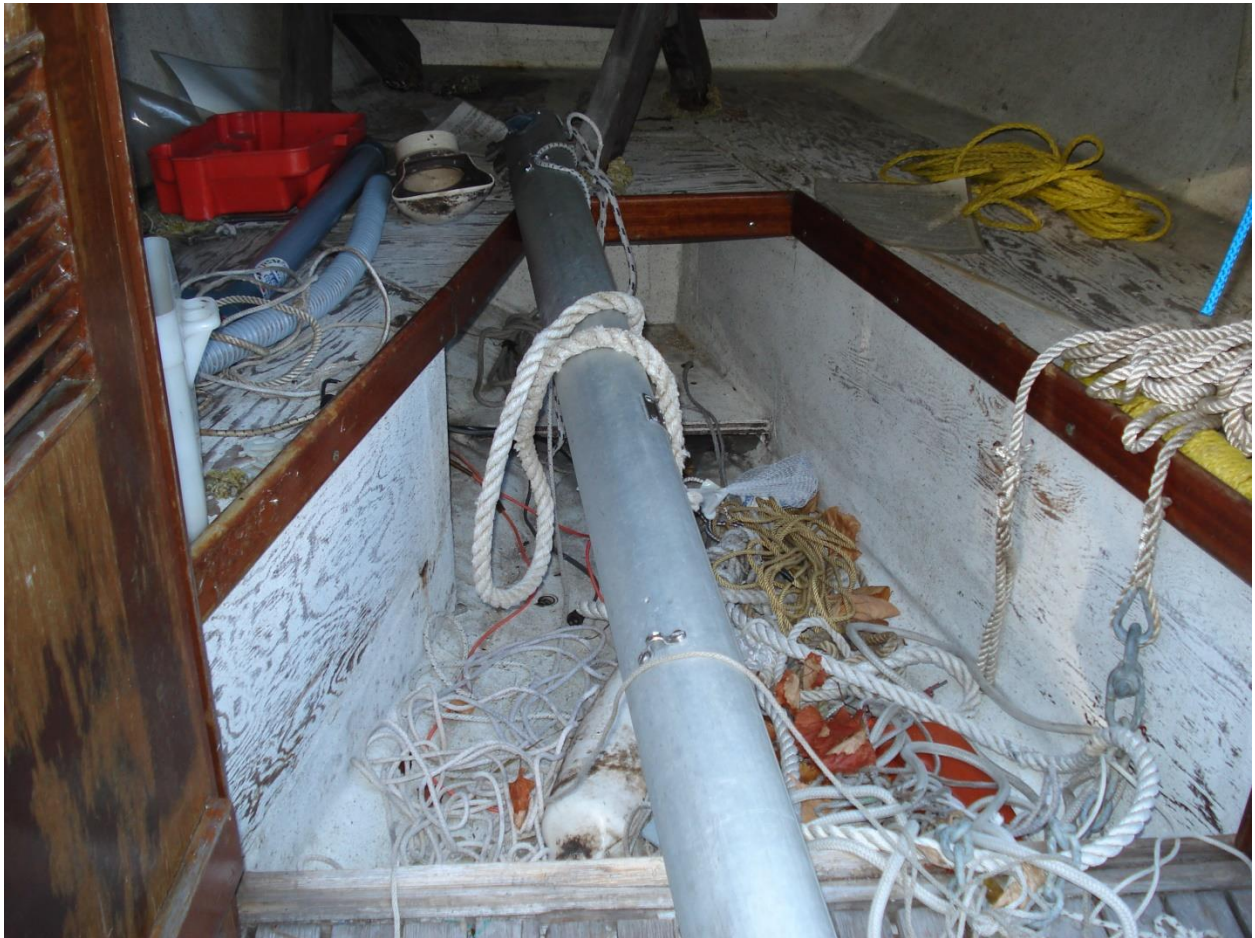
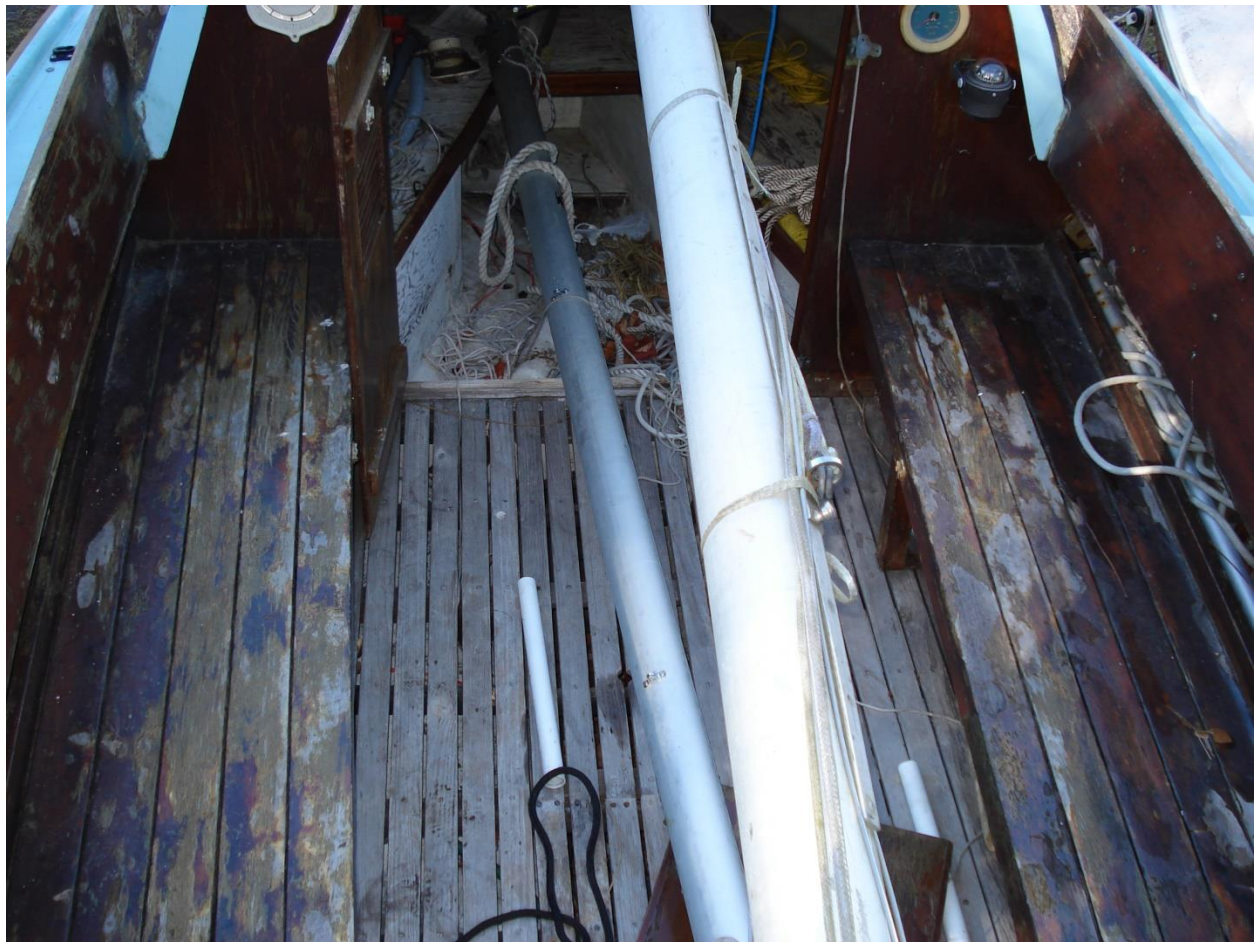
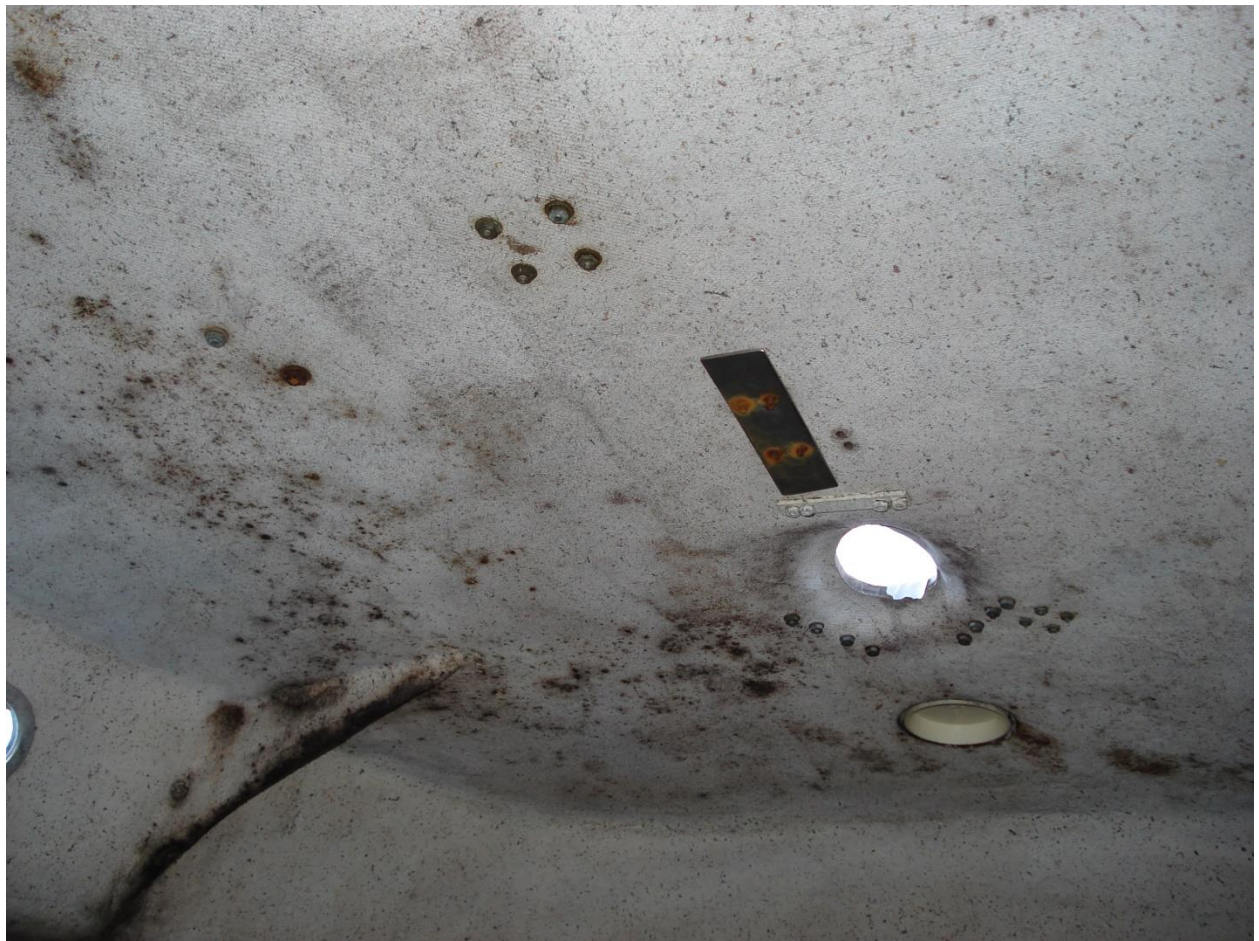
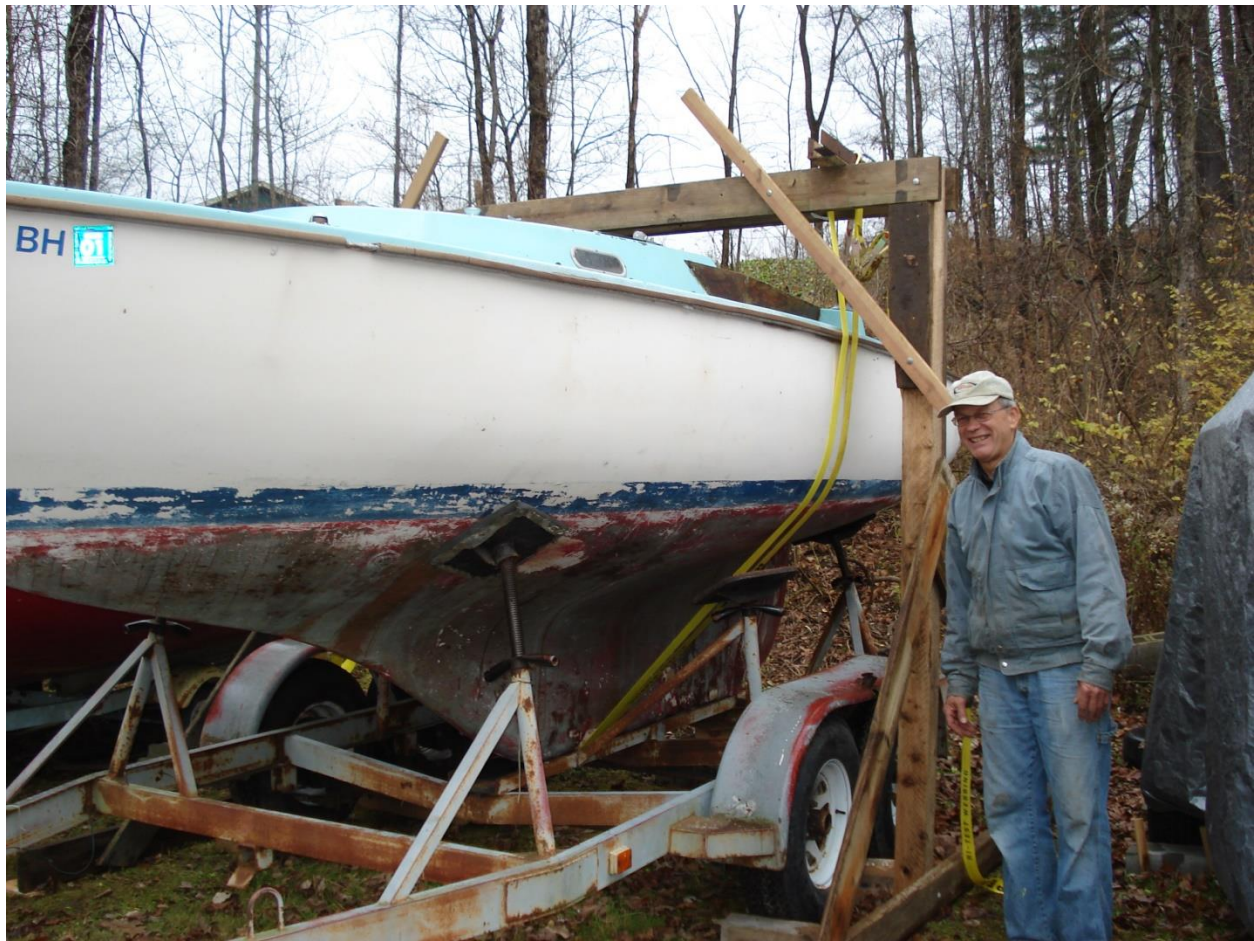
Our first project activity was to pick up #114 at a Canandaigua, NY marina, and take a look at our new pride and joy. Like most Ensigns, the hull below the flange was solid. The cosmetics, as expected, could kindly be described as needing considerable attention. The major project challenge was clearly the soft and spongy condition of the foredeck, cabin top, and stern deck. We used Dave's trailer for the move to the Saratoga Lake Sailing Club. A lifting stand was constructed to assist in transferring the boat from the trailer to stands in the SLSC boat storage area where the boat was put to sleep for the winter.

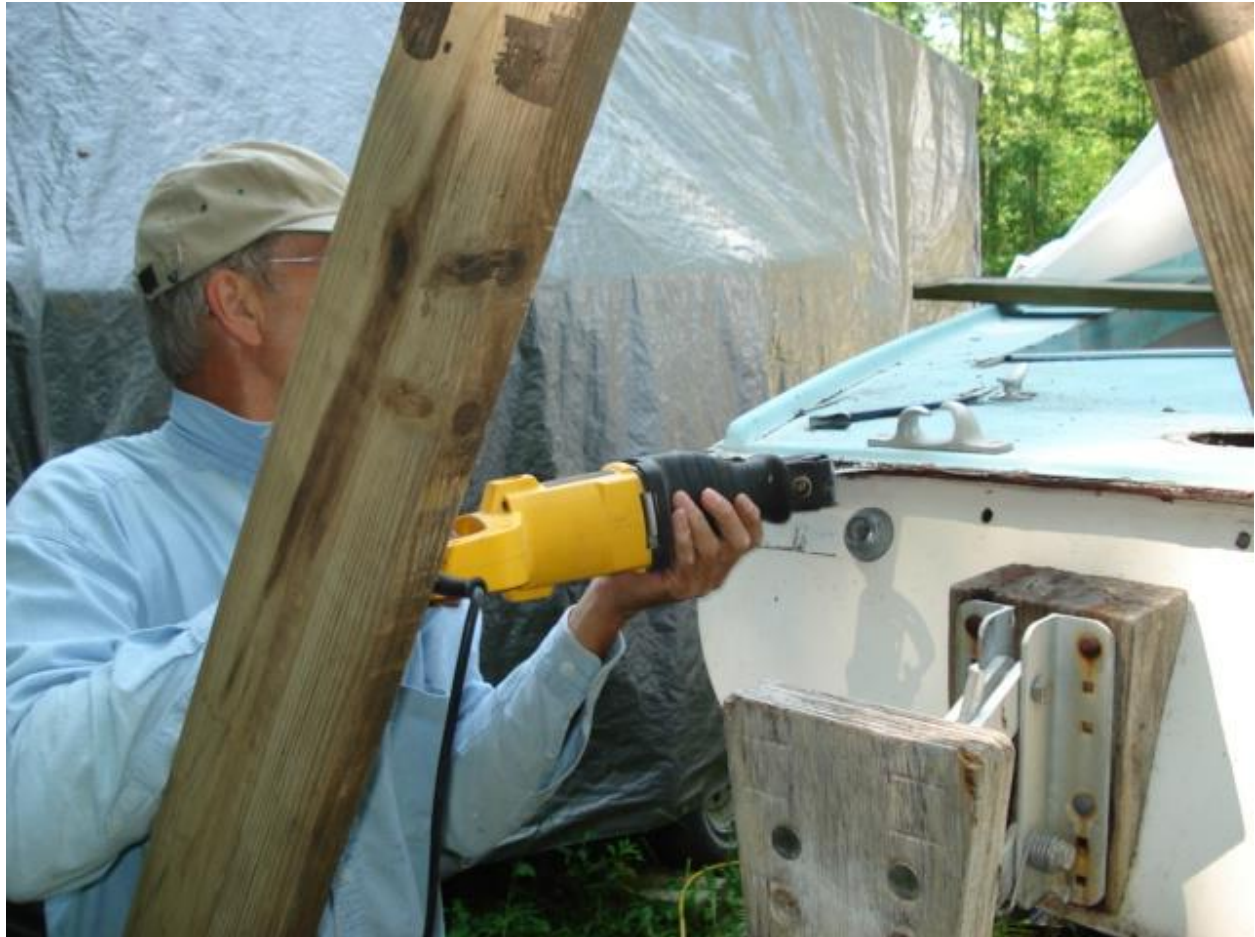
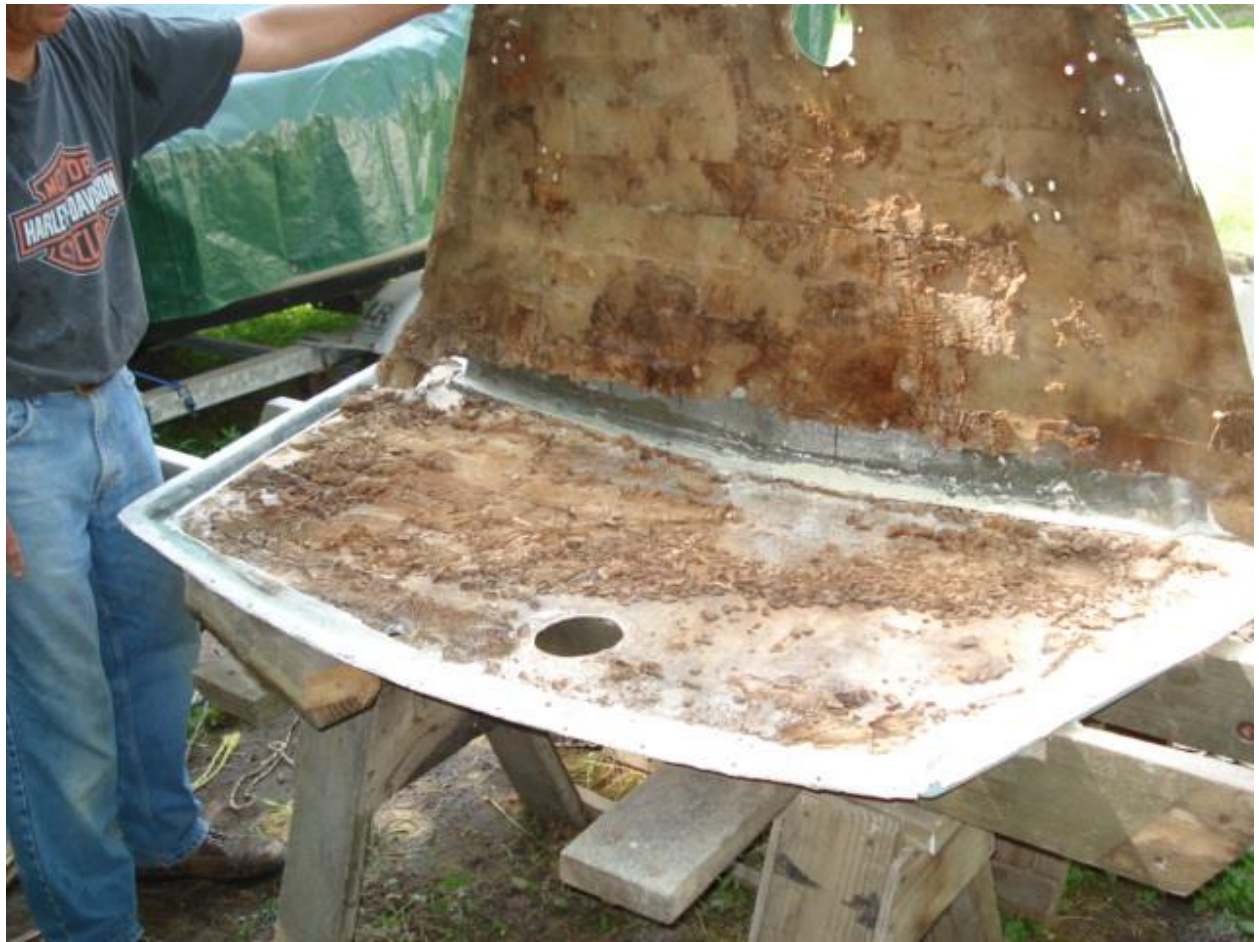
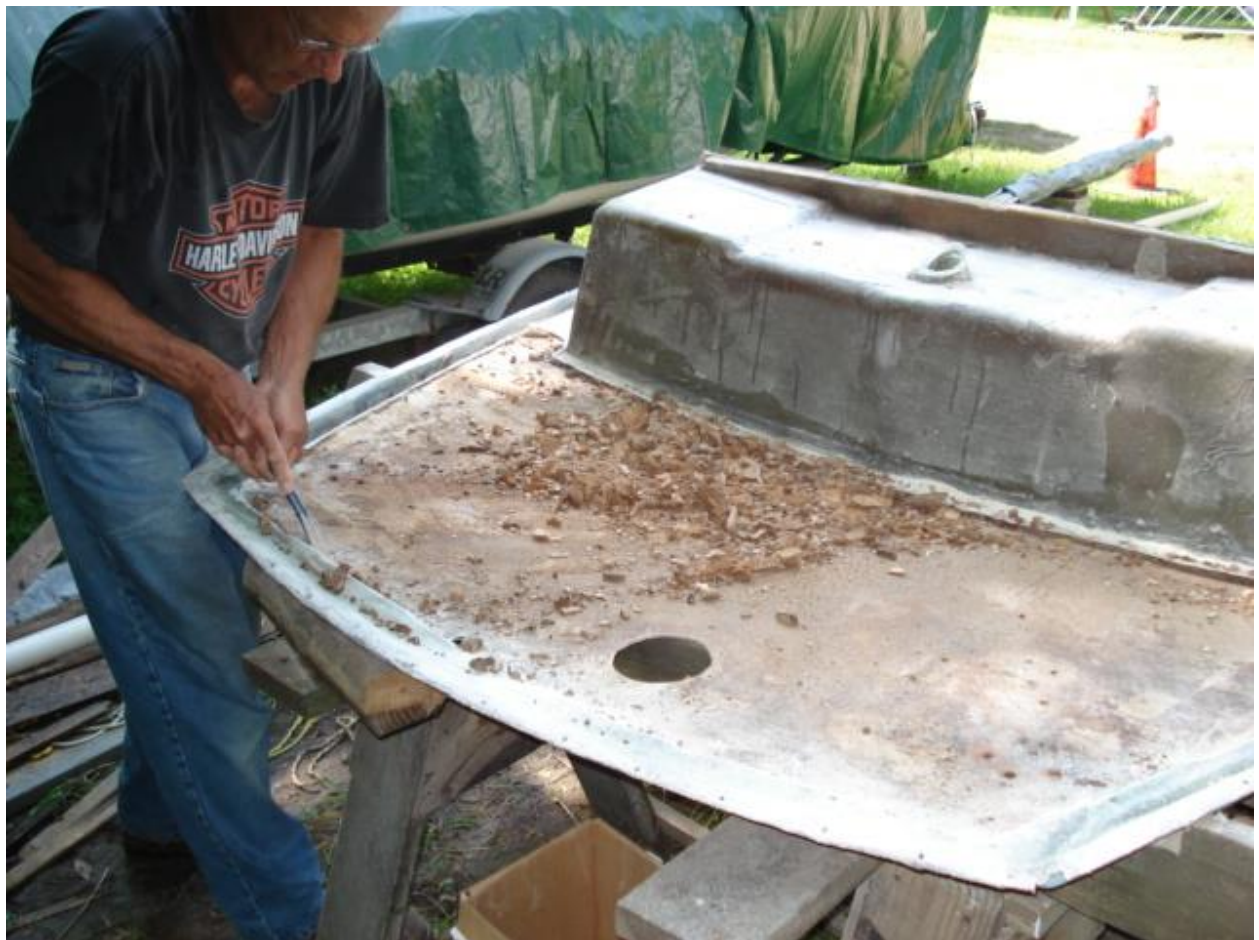
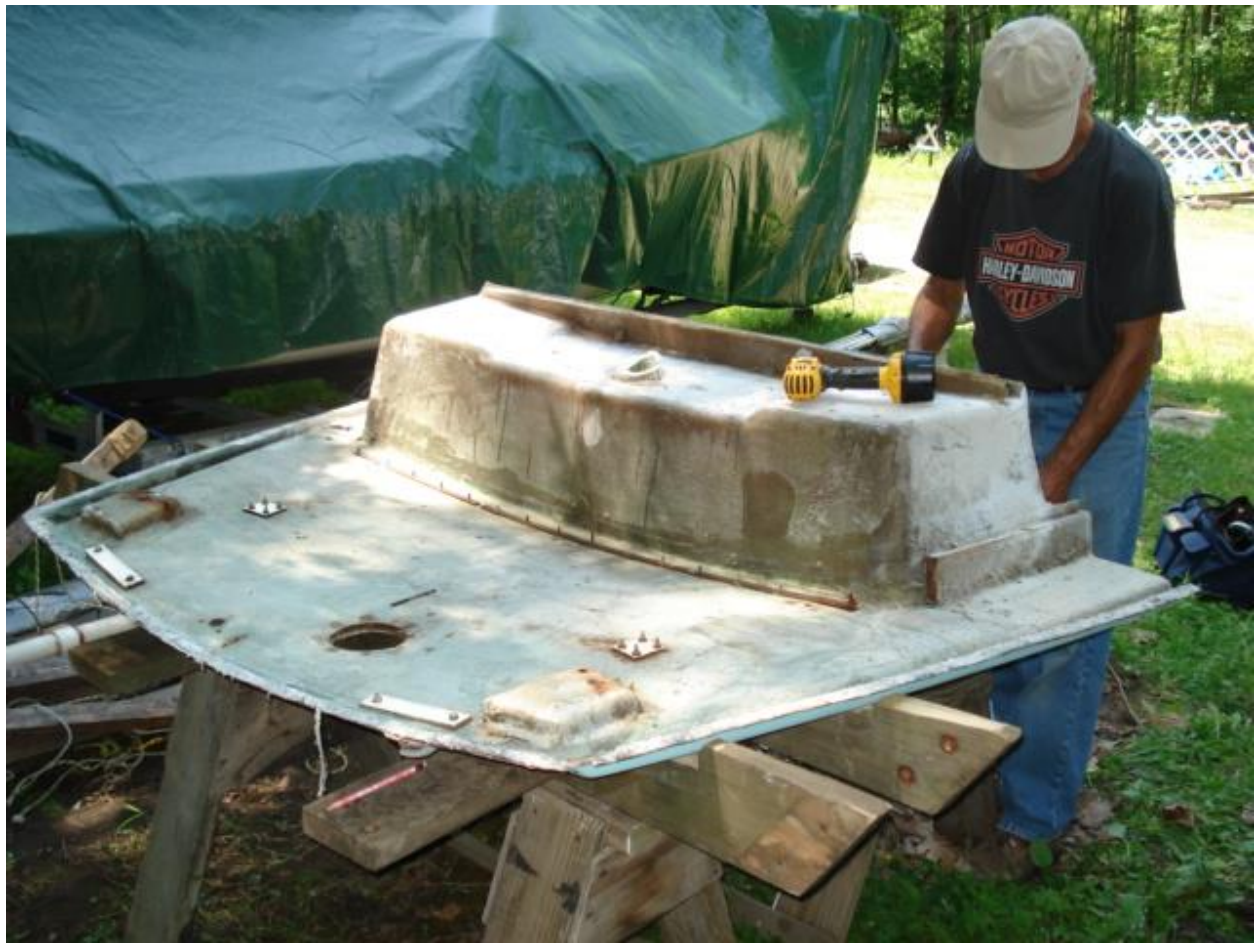
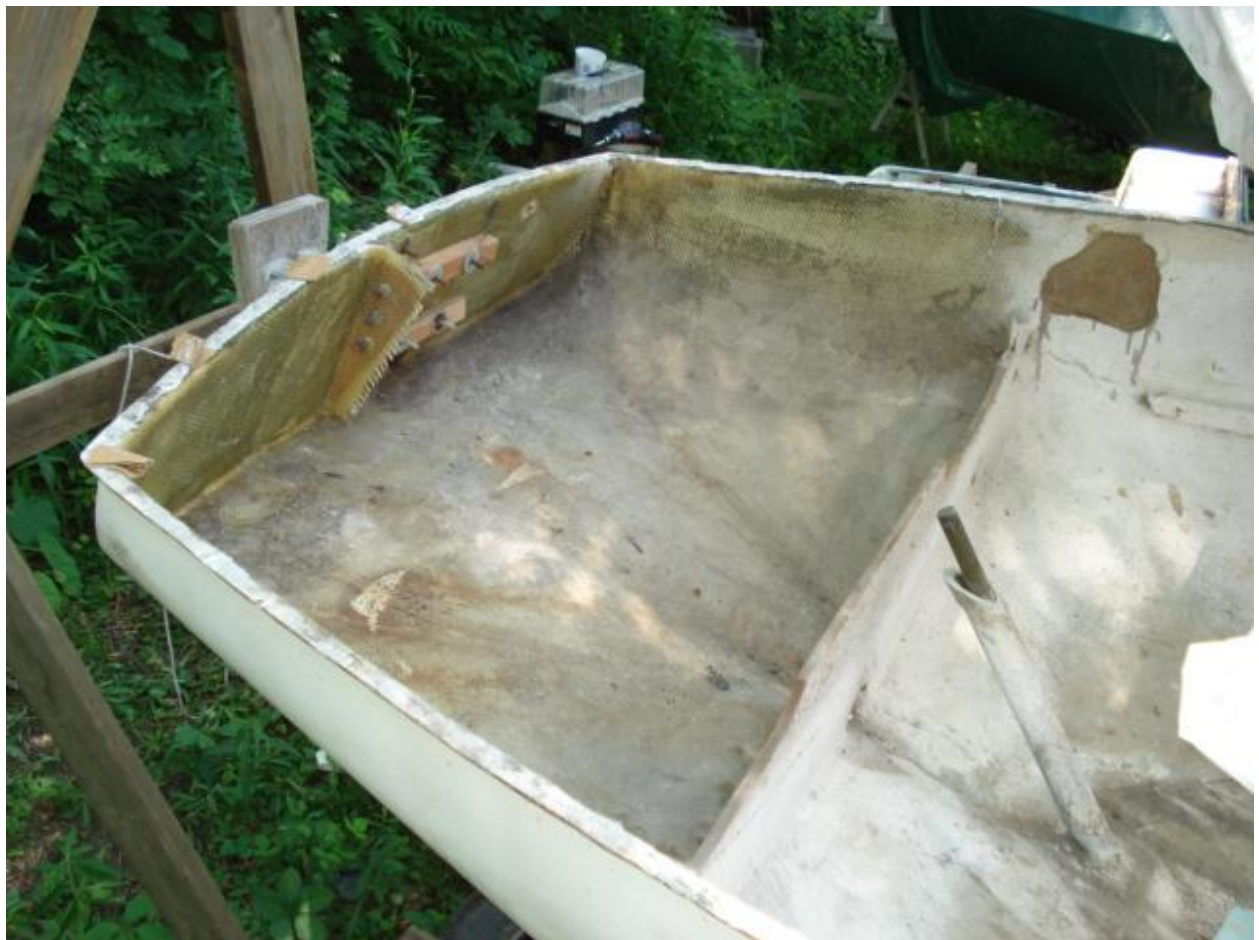
We elected to begin our recore process with the stern deck section. This smaller section would give us the experience and confidence needed to tackle the much larger foredeck/side deck/cabin top unit. We also had the benefit of viewing the VCR that Zeke Durica documented on this method of stern deck repair.

With the coming of spring, our project work got underway. In keeping with our goal to restore Ensign #114 to a like-new condition, we made a decision to remove all balsa from the fore deck, rear deck, side deck, and cabin top. The construction of the decks and cabin top of the Ensign can best be described as a sandwich consisting of a balsa core between two layers of fiberglass. The balsa would be removed and replaced with Core-cell closed cell foam which is the material used by the premier custom boat builders such as Hinckley Yachts.

The only practical way for us to undertake such a complete restoration was to separate the deck from the hull so that the underside of the deck and cabin top surfaces were completely exposed. These sections were placed on a contoured work frame to preserve the original deck contours during the recore process. The underside of the fiberglass sandwich was cut away and the entire balsa core was removed. Closed cell foam was installed to replace the balsa, and a new layer of fiberglass was laid up to complete the new sandwich. This process enabled us to maintain the integrity of all the original deck and cabin top outer fiberglass surfaces. In addition, with the hull wide open, we were able to examine areas of the Ensign not normally accessible with a localized repair. Corrective action, such as the replacement of the king plank and the cabin top ribs, was taken where needed. With the re-coring

completed the decks and cabin top sections were reattached to the hull. 3M 5200 Adhesive was liberally applied to the flanges prior to rivet placement.

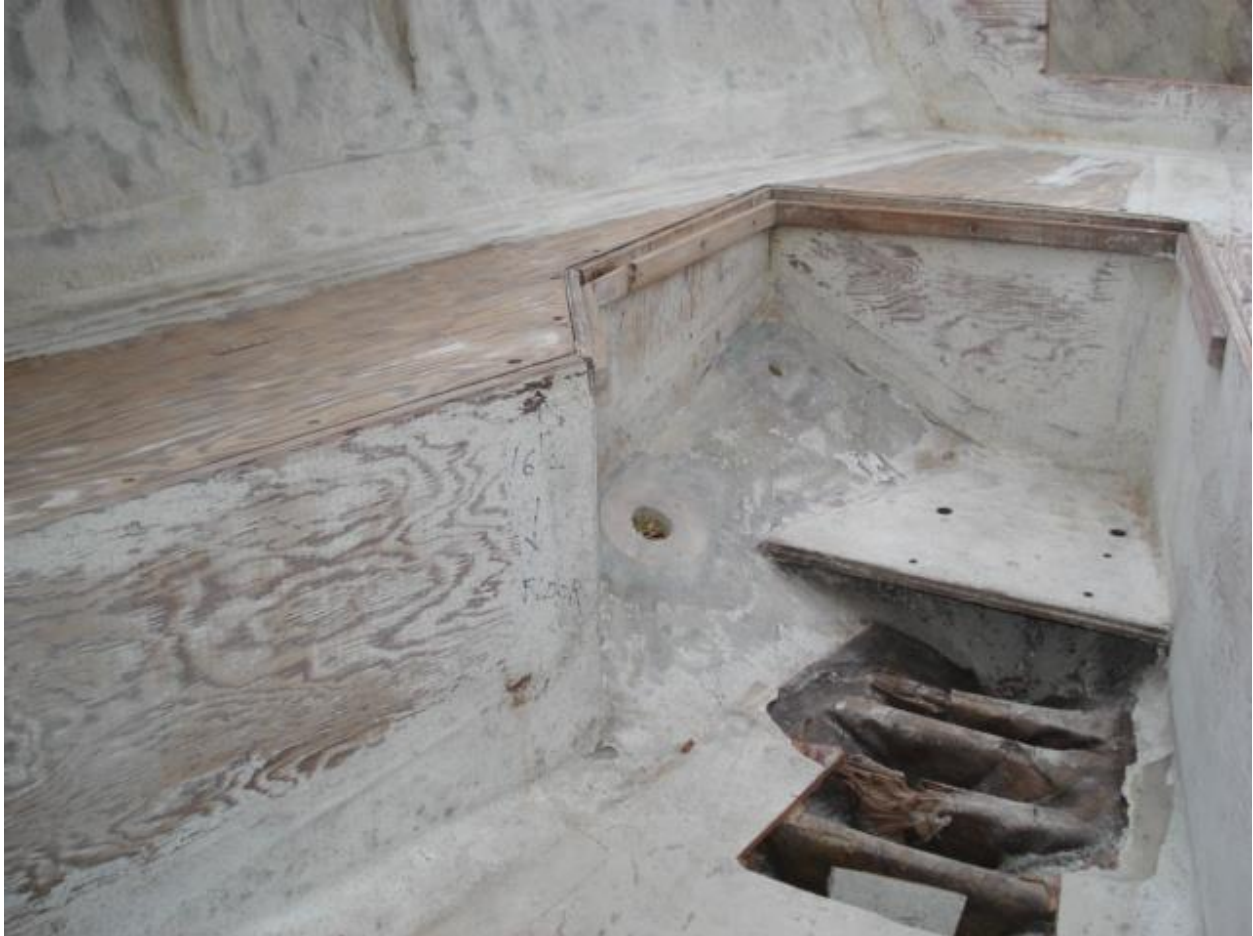
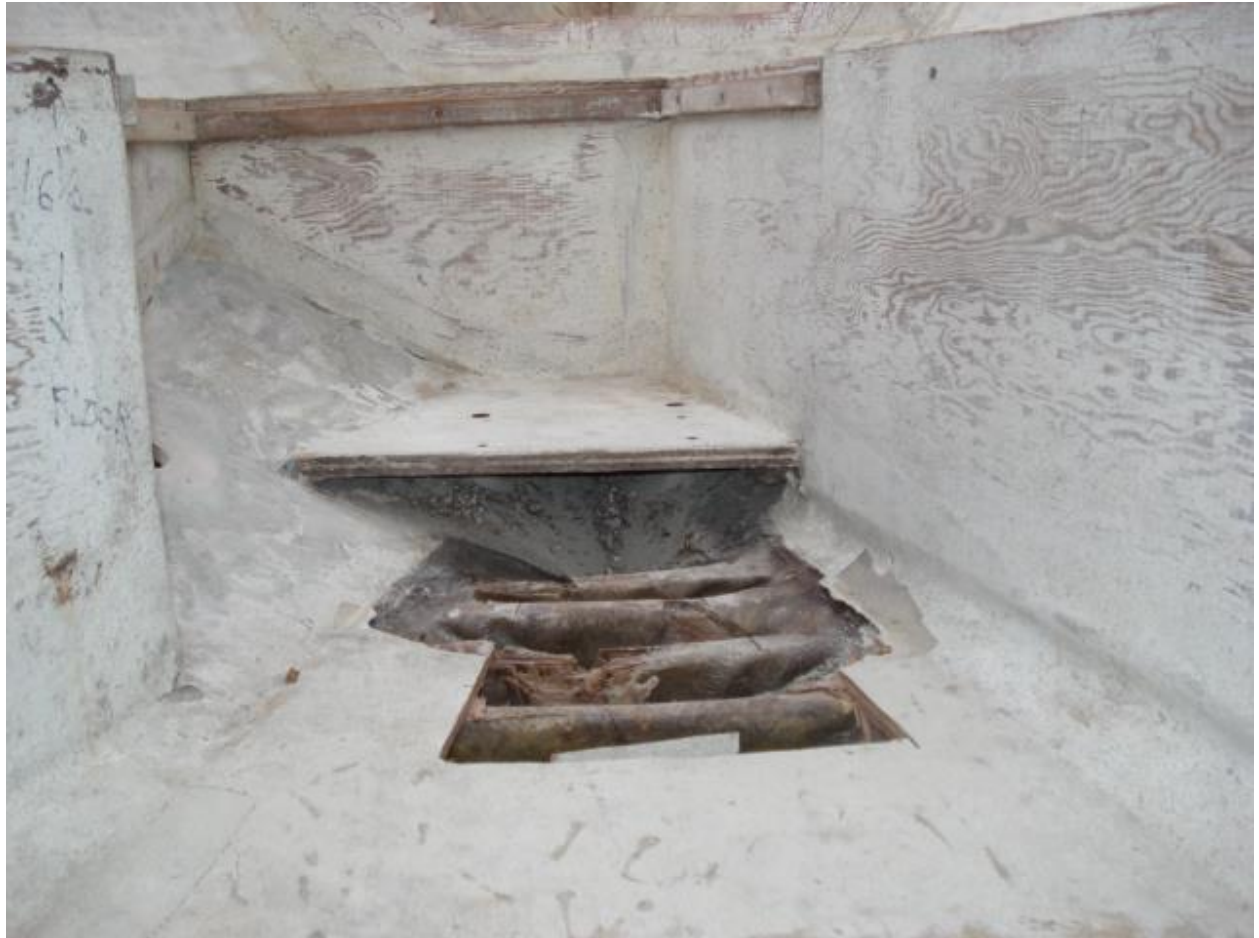
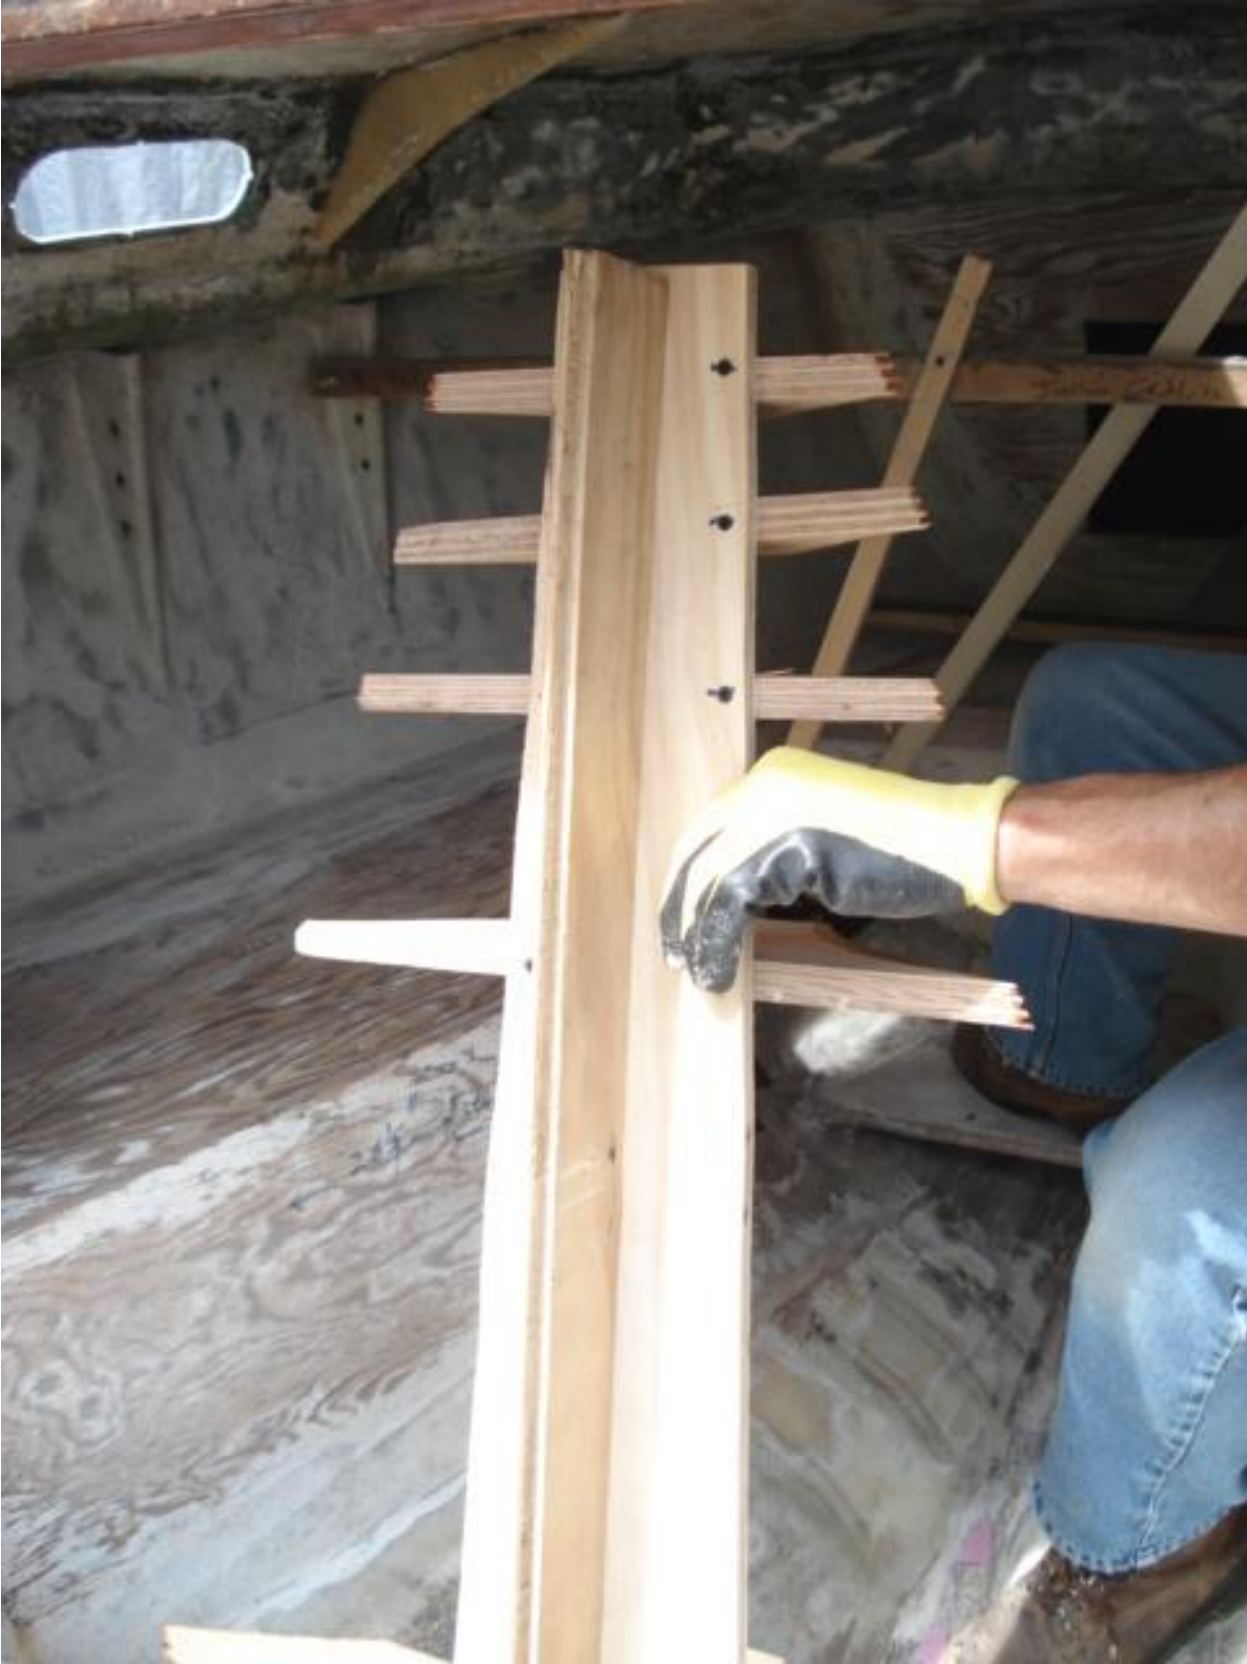
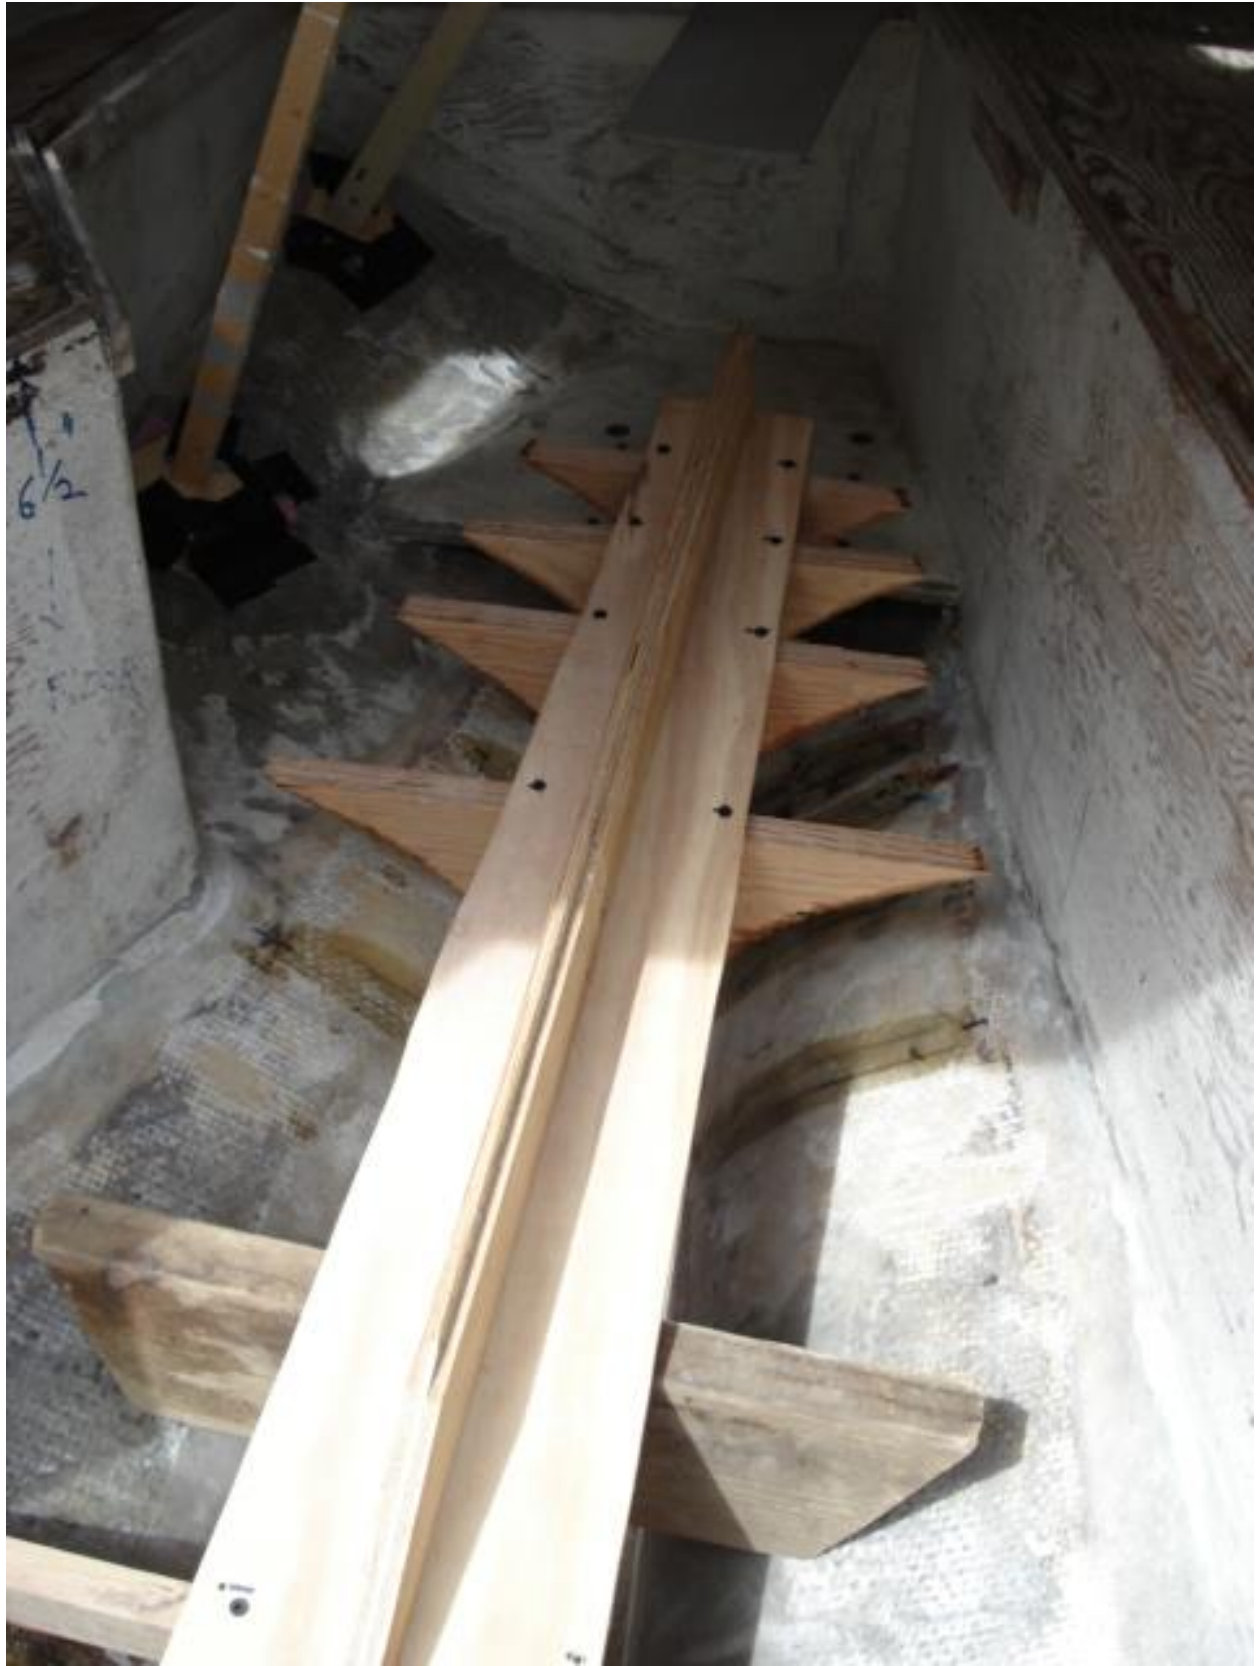
Not surprising for a 40+ year old Ensign, the 4 mast step supports under the cabin floor were rotted and needed to be replaced. We devised a hinged jig to assure that, when installed, the individual supports would be fully aligned with the new cabin floor.

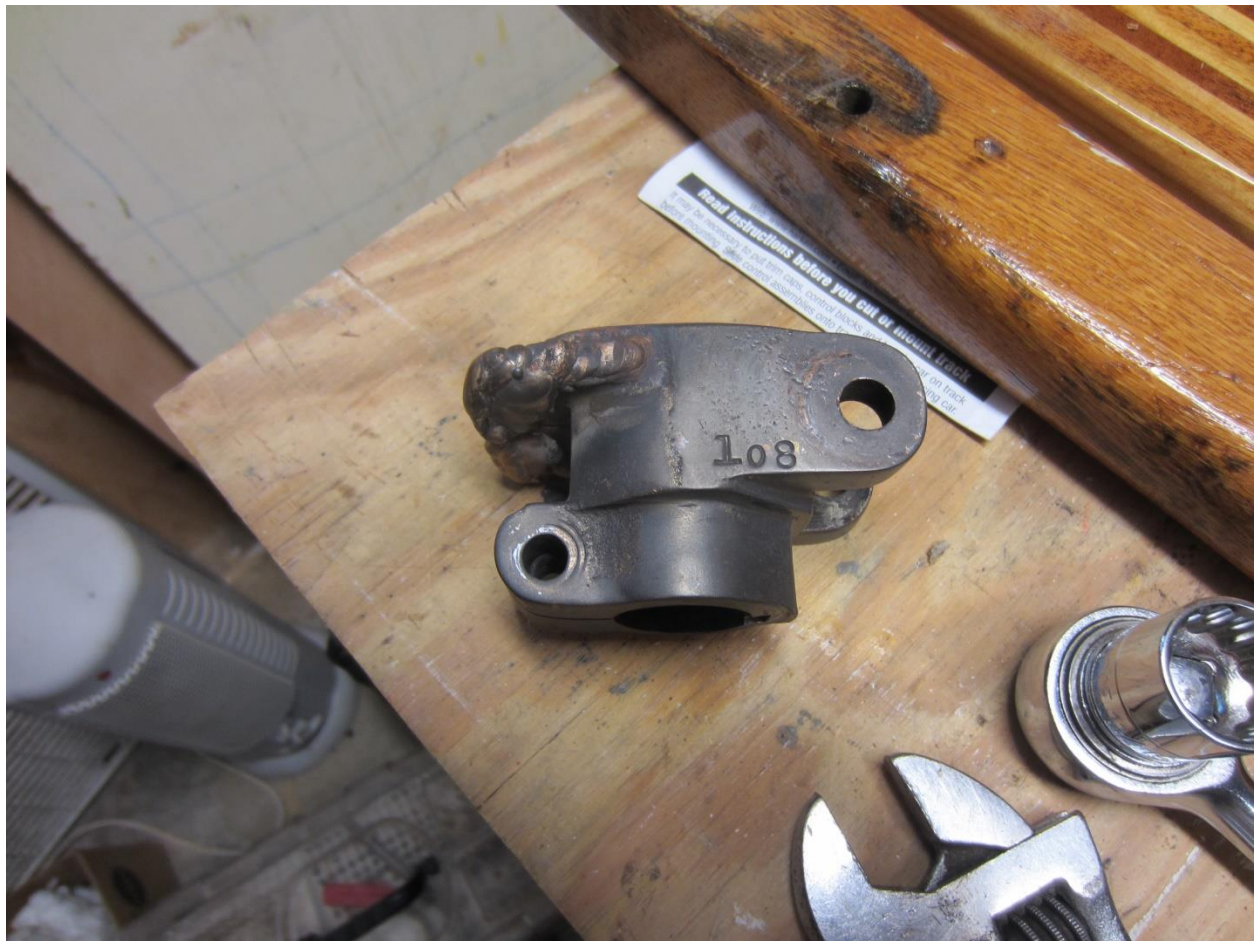
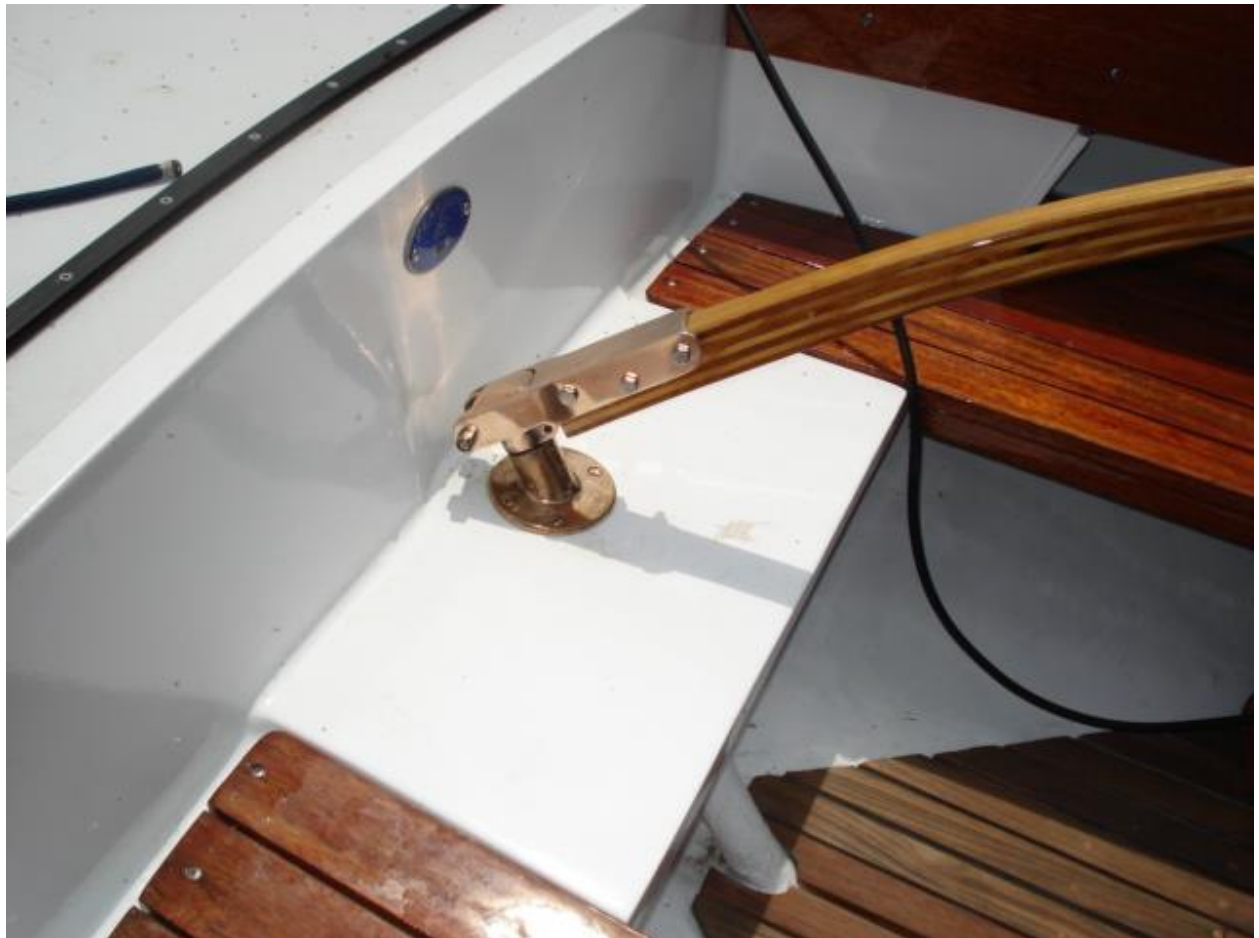
We've tried to capture the highlights of our restoration of Ensign #114, but every restoration also includes numerous items that are individually small, but collectively make all the difference in the world. As an example, when we acquired #114 the tillerhead assembly allowed the tiller to flop down when released. The two tabs that kept the tiller level were missing. We had a local shop weld on the proper bronze tabs. With some grinding, filing, sanding and buffing of the original fittings, the tiller assembly looked and functioned like new.
