Rock Hall Yacht Club Shoreline Management Plan (SMP)

1. SMP Background

6.1. Shoreline Condition and Stabilization

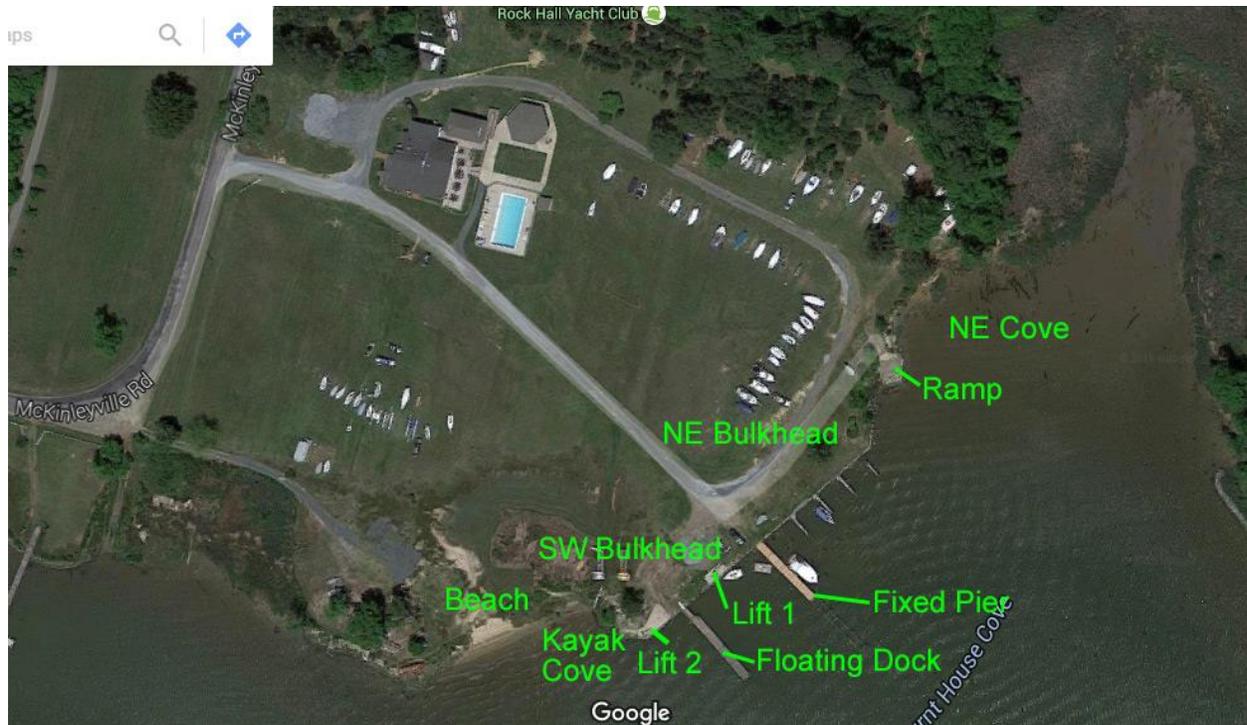
There are 9 elements of the RHYC working waterfront. These elements comprise the RHYC shoreline. The aerial photo of the RHYC grounds depicts each of the 9 elements. They are described below, in North to South order.

Figure 1. Aerial view of RHYC shoreline

1. NE Cove -200' living shoreline
2. Ramp – concrete and gravel shallow small boat launch only
3. NE bulkhead (North of fixed pier) 200' timber bulkhead
4. SW bulkhead (South of fixed pier) 200' timber bulkhead
5. Fixed pier and finger piers – timber on pilings
6. Lifts 1 & 2 – Lift 1: 1 ton lift with large arm, Lift 2: 1 ton lift with smaller arm
7. Floating dock – built 2008?
8. Kayak Cove / wetlands – 75' living wetlands/phragmites/shoreline
9. Beach – sandy beach extending into living shoreline on both sides

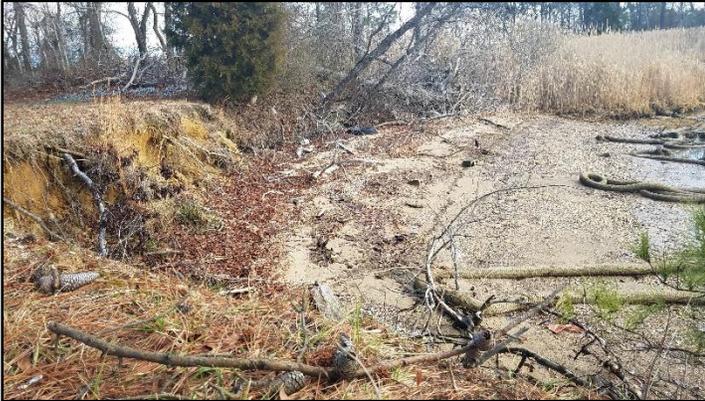
1. NE Cove -200' living shoreline
This portion of the shoreline is unused by the club. It currently has steep vertical banks which make access very difficult. Further this area is losing over 1' of shoreline property per year due to high wave energy from the long fetch from the SW across Langford Bay. The water in the NE Cove is very shallow, often 0' at low tides due to the eroding banks. Maximum water depth is 1' at high tides until approximately 300' from shore. Several trees along the shoreline have been

lost over the past several years as the soil holding their root ball is washed away. Several more trees are in jeopardy in the next 2-3 years if the shoreline is not stabilized. The area is currently unusable, not maintained in any way, and could be a safety hazard.

Figure 2. NE Cove Fall 2016

Starting in the NE Cove, we propose stabilizing the banks with coir/biologs/oyster bags and providing a oyster reef for wave attenuation and an oyster sanctuary. The oyster reef will encourage additional aquatic wildlife and naturally grow in size and weight overtime, providing energy attenuation and protecting the living shoreline in the cove. The existing ramp will be removed and become part of the living shoreline, allowing a sandy, natural, gentle sloping access to shallow waters for young children, kayakers, and shallow water activities.

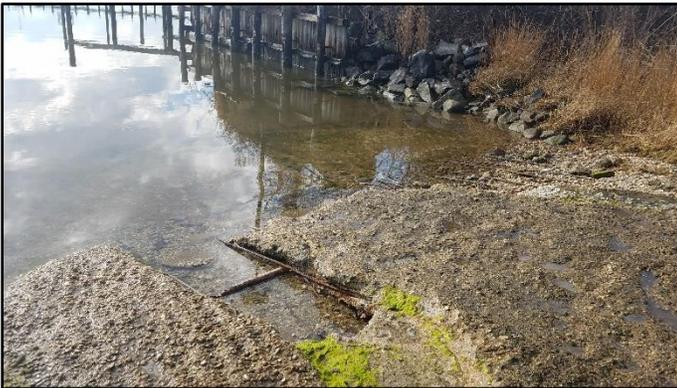
The boat ramp is constructed from poured concrete and rebar. Approximately 10 years ago it was useful to launch small (less than 16') shallow draft power and sailboats on towable trailers. The water depth off this ramp is at most 2'. In the past 10 years, the ramp has not been maintained and was closed in 2016 as unsafe and unusable. There are holes in the concrete where tires and feet can get stuck or damaged and rebar is poking through. The ramp was patched with crush & run gravel in late 2016 which made it possible for Fall use for very small boats. The gravel has since washed away due to high wave energy. The ramp is currently unsafe and unusable, and due to the very shallow water depth not worth fixing.

Figure 3. Boat Ramp showing deterioration and exposed rebar

There will be a new ramp constructed by cutting through the North section of bulkhead and grading as needed. The ramp is envisioned to have a floating dock on the north side to facilitate launching and retrieval of small craft.

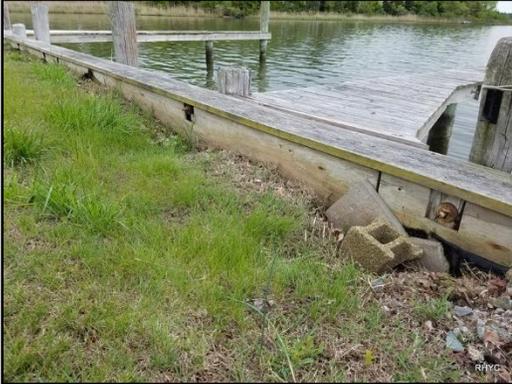
The bulkhead was originally constructed in 1965. In 2013, the entire bulkhead was determined to be "in a state of advanced decay and is in need of full replacement" by Marine Technologies, Inc. visual and underwater assessment. In Spring 2016 there were huge (4' long and 3' deep) washout sink holes behind the bulkhead which were patched with gravel. These washouts re-occur each year and are gradually getting worse as the integrity of the structure is continually battered by the high energy waves and the rotten timbers allow more soil to washout. Since

December 2016, the Waterfront Committee has walked the site with 5 dock contractors, all of whom recommend bulkhead replacement. There is not sufficient structure remaining to repair the existing bulkhead. Regatta and marina operations at the RHYC would allow for this section of bulkhead to be replaced with a living shoreline which would protect the land from waves while also allowing habitat for wildlife.

Figure 4. NE Section of Bulkhead - Spring 2016 - showing one area of washout

North of the fixed pier, the bulkhead will be replaced with living shoreline with a toe. The existing finger piers will be removed. This living shoreline will provide a gentle sloping natural delineation between the grassy area and the water which will absorb energy, storm surge, and flooding. This living shoreline will be planted with indigenous plant and shrubs and enhance the club's vista as well as the connection to the water. Living shoreline is less expensive to install than replacement bulkhead and after initial install will be more maintenance free. The replacement of the bulkhead with living shoreline should also allow a smooth permitting process as it is favored by county and state regulatory agencies.

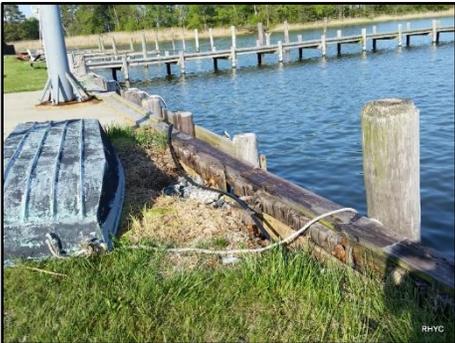
4. SW bulkhead (South of fixed pier) ~200' timber bulkhead
Please read NE bulkhead for condition assessment of retaining wall structure. This SW section of bulkhead is crucial to retain as bulkhead for boat lift operations as well as regatta operations. Both boat lifts are along this section of bulkhead and require the support of a bulkhead as well as the vertical drop-off for launching and retrieving boats on the sea side of the lifts. This is the most critical element of RHYC shoreline at this time, it is in an advanced state of decay and failure, the integrity of the boat lift's foundation is at risk, and the area is unsafe after major storms due to washout, and it compromises the continuation of the RHYC regatta programs which is a major source of income and pride for the club. Replacement of this SW section of bulkhead is the highest priority for shoreline management.

Figure 5. SW section of bulkhead - Spring 2016 - showing shore washout and deteriorating timber and hardware

The South section of bulkhead will be replaced with vinyl bulkhead which lasts far longer than timber-only. The existing floating dock will be retained and rebuilt in the next few years. Lift 1 will need piling reinforcement under its concrete footing. Lift 2 can be retained or removed and sold. Both lifts may need modification to be fully operational following the bulkhead replacement, as the replacement is done to the waterside of the existing bulkhead and will add 18" to the shoreline.

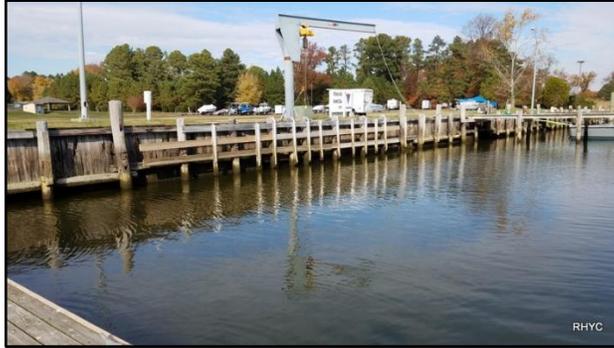
Figure 6. SW bulkhead with Lift 1

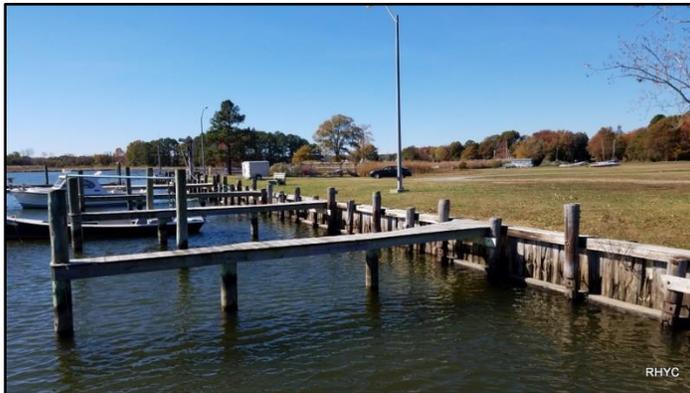
In 2013, the fixed pier and finger piers also were assessed by Marine Technologies, Inc. as being in overall satisfactory condition. Since that time, the identified component issues were largely resolved with, new stringers, re-decking and replacement of several failing pilings. The fixed pier is currently adequate and safe. The finger piers are adequate to service the 7 current marina slips along the bulkhead. There is however continual degradation of pilings, stringers, and deck boards which should be addressed and maintained on an annual basis.

Figure 7. Finger Piers / Marina Area

The existing fixed pier will be retained and reinforced as needed. An L will be created, extending the dock to the North. Under the corner pf the L, wave attenuation will be installed to reduce wave energy and create a safe and low energy marina basin. Dredging may be necessary, and if permitted, material could be used to fill the NE Cove or the kayak cove. This will be determined after bathymetric studies are complete. New finger piers and pilings will be installed perpendicular to the existing fixed pier to allow

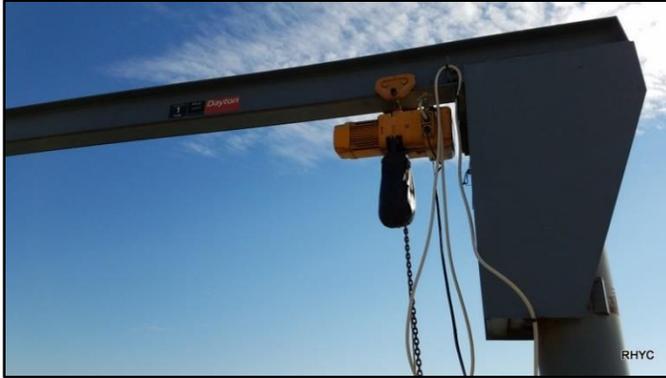
Figure 8. Lift 1

Lift 1 is a 1 ton lift with large arm on the bulkhead just north of the floating dock. Lift 1 is in satisfactory condition and services approximately 200-300 small sailboat and power boat launches and retrievals each summer/regatta season by RHYC Members and RHYC Regatta competitors. There have been some issues with the usage of the lift and limit switches have been installed to prevent motor overload. The motor on the lift has not been, but should be serviced annually. Lift 1 was installed in approximately 2003 timeframe.

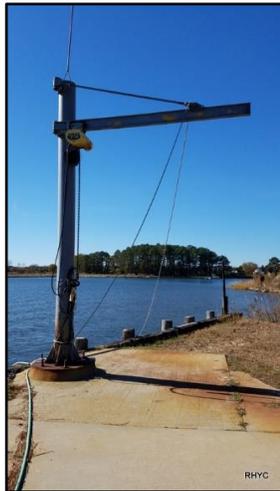
Figure 9. Lift 2

Lift 2 is also a 1 ton lift with smaller arm located on the bulkhead near the southern end. Lift 2 is older than Lift 1 but we do not have information regarding the year of installation. Lift 2 is not used as frequently as Lift 1, but is used for regattas, especially the larger regattas where there is contention for the lifts. Lift 1 also has had a number of repairs in 2016 it was repaired by an electrician 3 times due to issues with electrical supply and limit switches. The motor on the lift has not been, but should be serviced annually

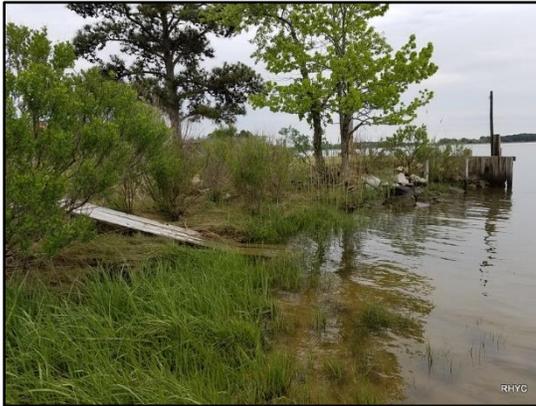
Southwest of the bulkhead is a wetlands area currently considered by Kent County to contain tidal and non-tidal wetlands. This area has a large area of phragmites which is currently being eradicated in cooperation with DNR / Chesapeake Wildlife Heritage (CWH). The first spray was Fall 2016 and RHYC has a 5 year permit by the State of MD to continue eradication. Phragmites can destroy a wetland’s biodiversity by choking out the beneficial wetland plants, eventually becoming a monoculture with little or no native wildlife value. However, a 5-year research study by CWH documented that once a pure stand of Phragmites was eliminated, 61 different species of plants emerged from the existing wetland seedbed. As we continue on this program to eradicate phragmites, this will enable more use by kayakers and other small boats to use this cove as an effective launch area. Additionally, per the County and DNR, the current path through the wetlands area must be addressed to eliminate trampling of existing wetlands. The

non-tidal wetlands is to be confirmed by MDE and if confirmed will be an area requiring additional protection from erosion and tidal influence which is occurring naturally at this time.

Figure 10. Kayak cove

The kayak cove shoreline requires reinforcement with coir/biologs and some wave protection in the form of oyster bags just off the bulkhead to ensure wave attenuation from the SW winds. A permeable wetlands walk is needed to allow access from the beach area to the bulkhead area. The permeable walkway will allow access while stopping the current trampling of the wetlands in that area. This walkway is key during regattas and also in facilitating a continual path along our waterfront.

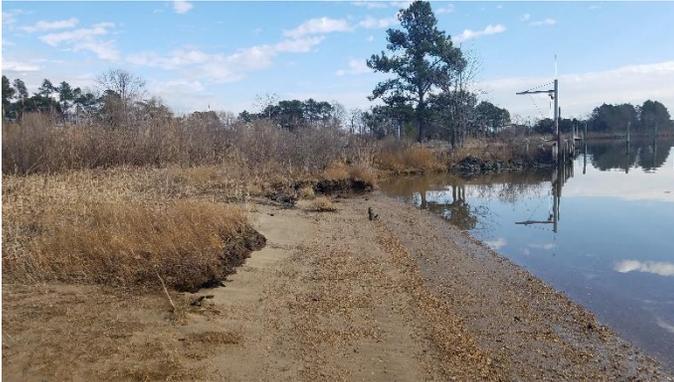
The beach area is naturally formed and a treasured resource for regattas, the sailing school, and young families for swimming, launching small sailboats and other vessels, and holding beachfront events and activities. The beach extends from the phragmites wetlands area to the duck blind and edge of the RHYC property (Parcel 77). The water off the beach is generally shallow and gentle sloping as distance increases from the shore. The beach has some periods of significant erosion particularly in winter, and seems to rebuild itself with spring winds. The 2005 addition of the Long Point structure has helped to protect the beach and the southwestern most part of the RHYC shoreline. Maintenance is minimal for the beach area, clearing brush, trash, and debris and removal of occasional timbers which are exposed in the underwater sand.

Figure 11. Beach area

Water and electric is needed near the beach area to facilitate maintenance, cleaning of boats and allow events to be hosted at the beach. A low profile dinghy dock in the waters south west of the beach would allow a fleet of sailing boats to be ready and accessible for summer months.

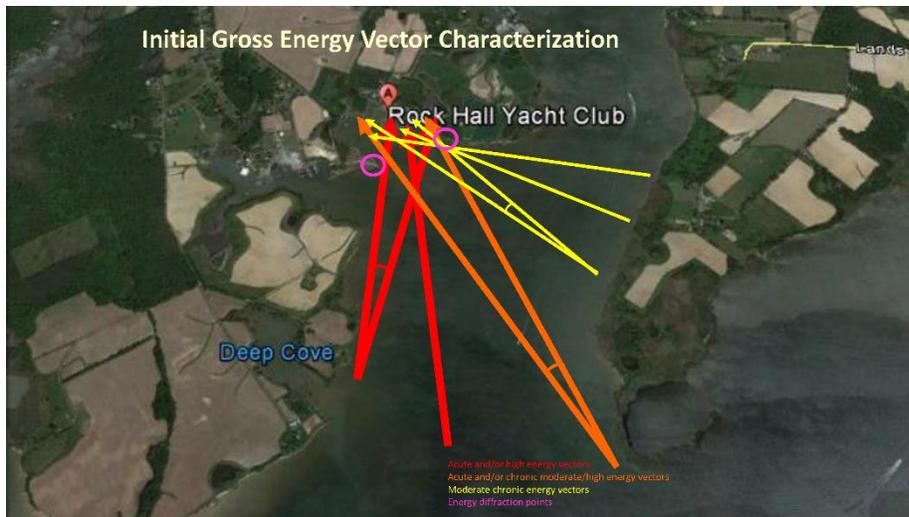
Wind and wave energy are key concerns along the majority of the RHYC Waterfront. The prevailing winds are from the SSW, as shown in the Figure 12 below. The long fetch from the Chester River into Langford Bay and to the RHYC shoreline create a very high energy environment. A 20 kt SSW breeze causes 2' to 2.5' waves against the bulkhead and into the NE Cove. This wave energy must be a consideration in all upgrades to the RHYC Shoreline.

Figure 12. Wind Energy Characterization at RHYC, courtesy of Sovereign Consulting

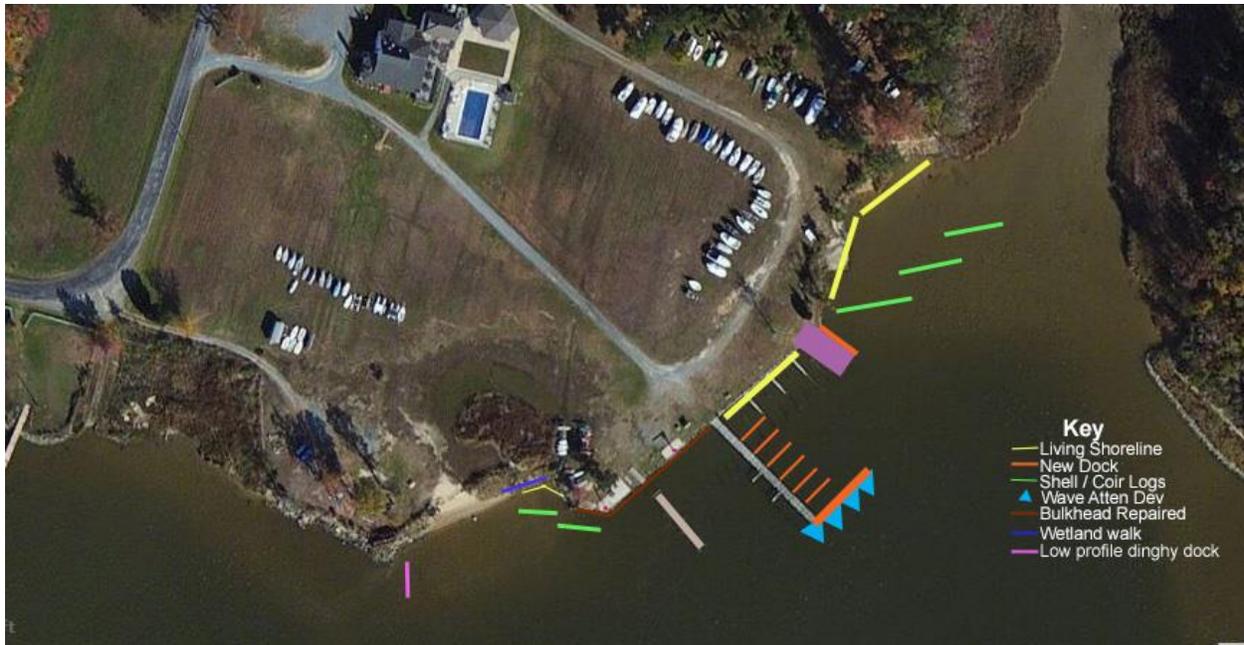
Figure 13. RHYC Waterfront Stabilization Concept
