The Restoration of Ensign #114 Windcaller

Background

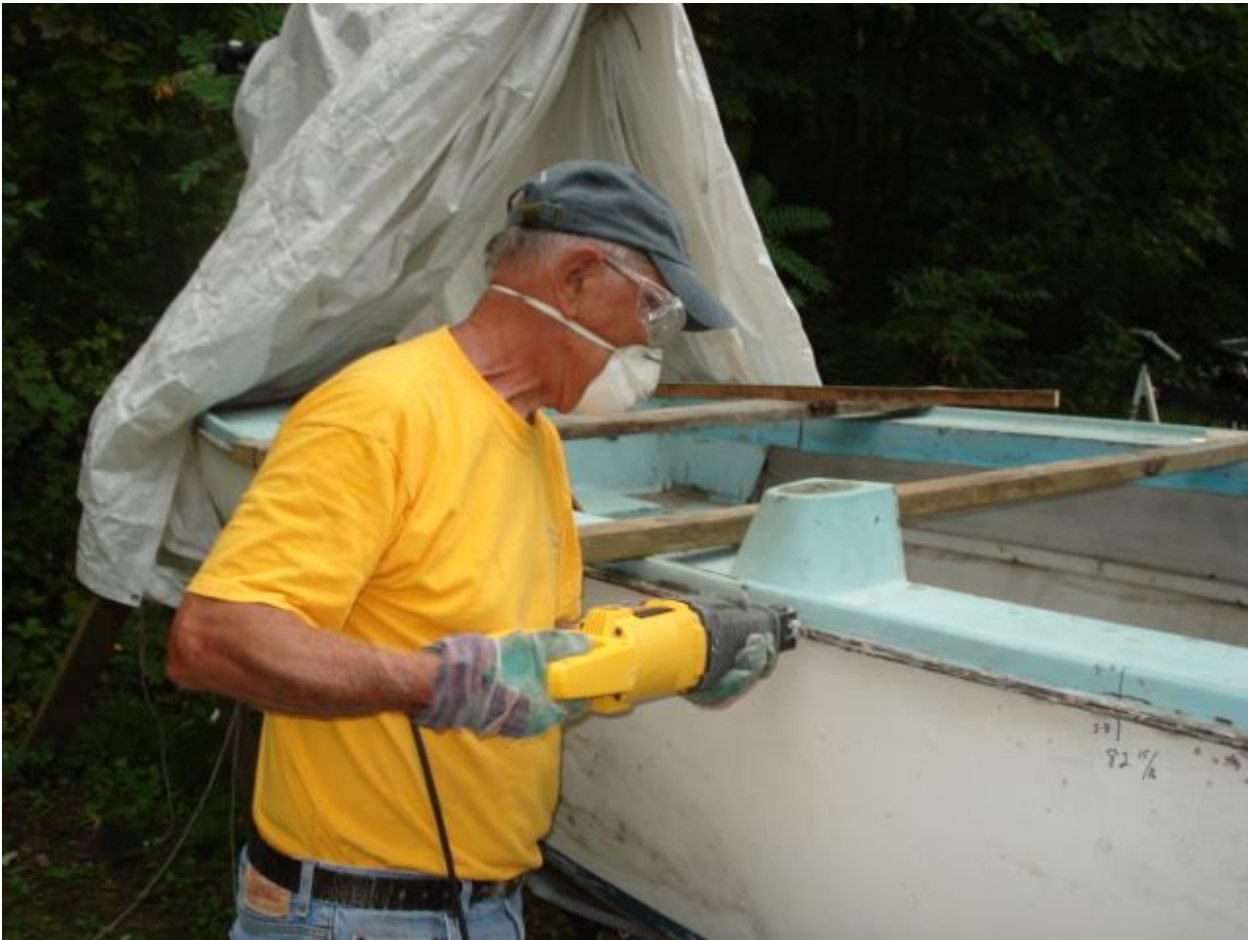
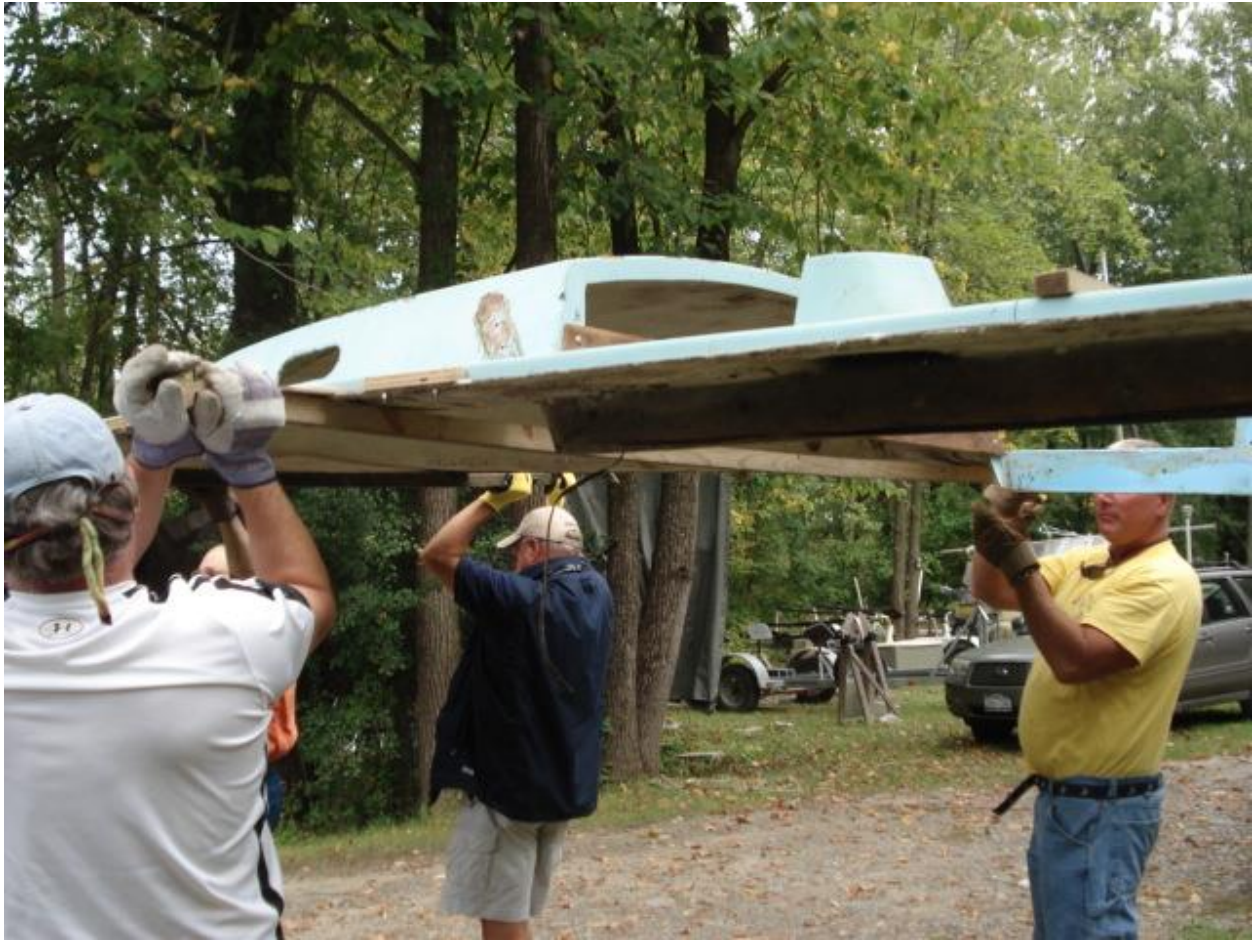
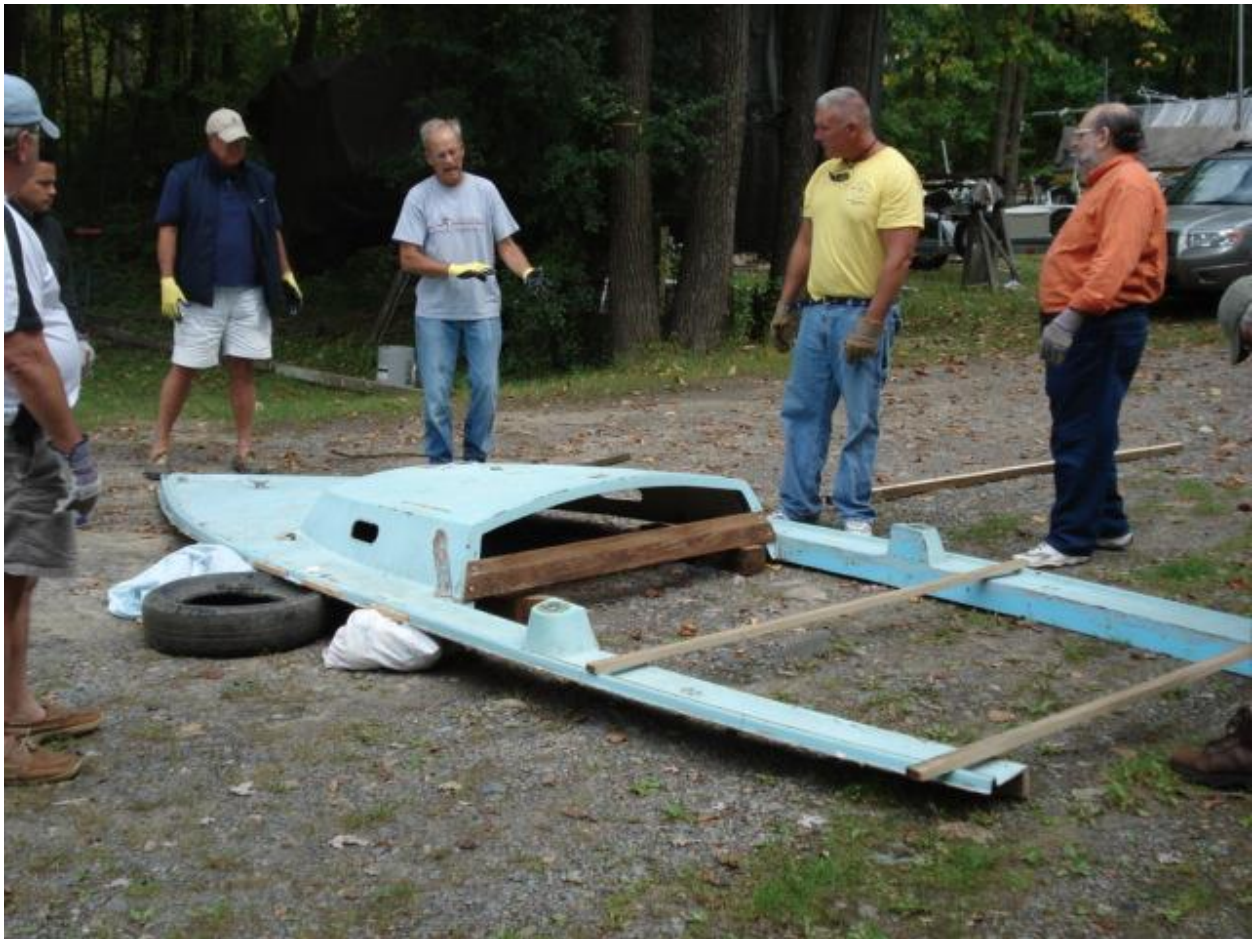
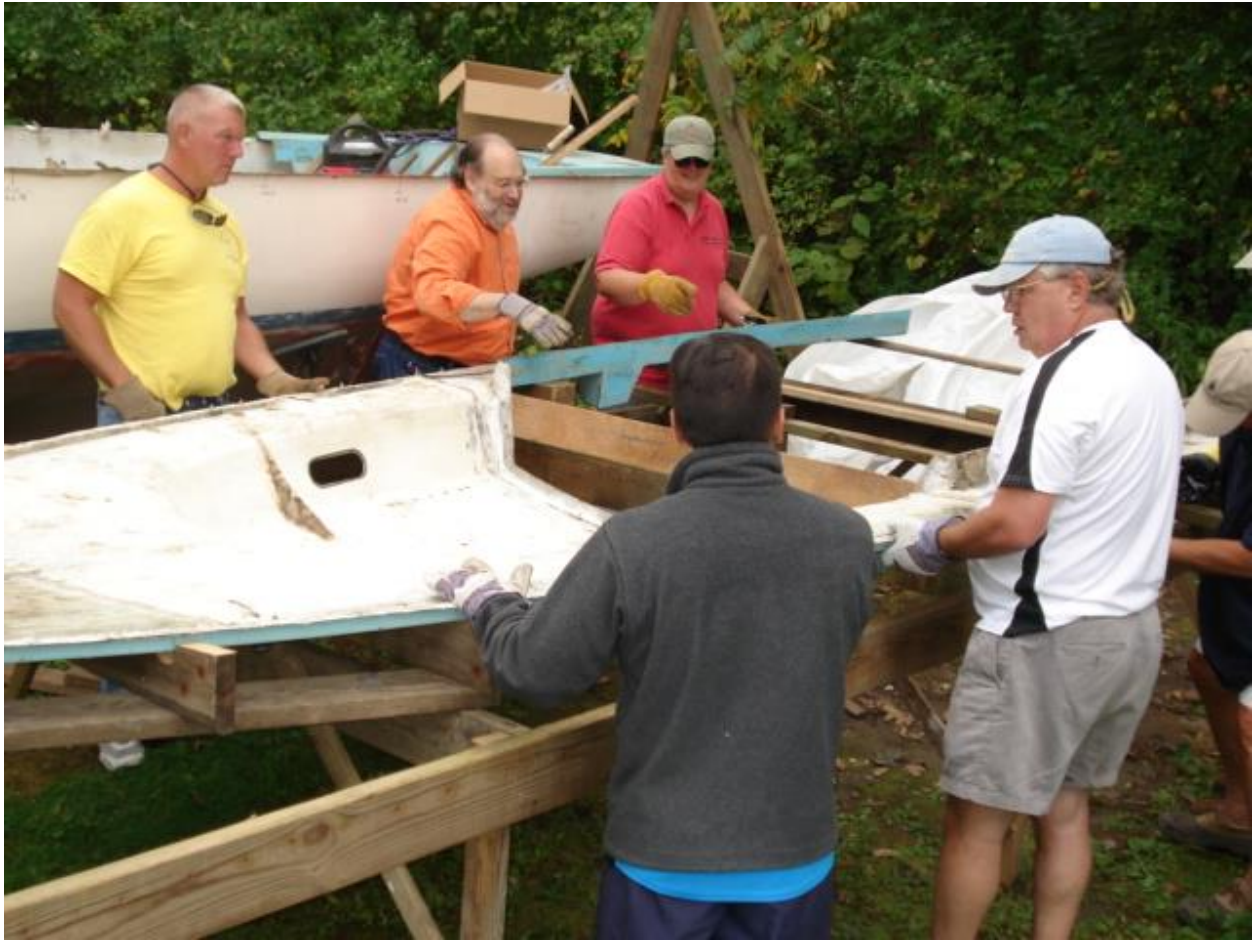
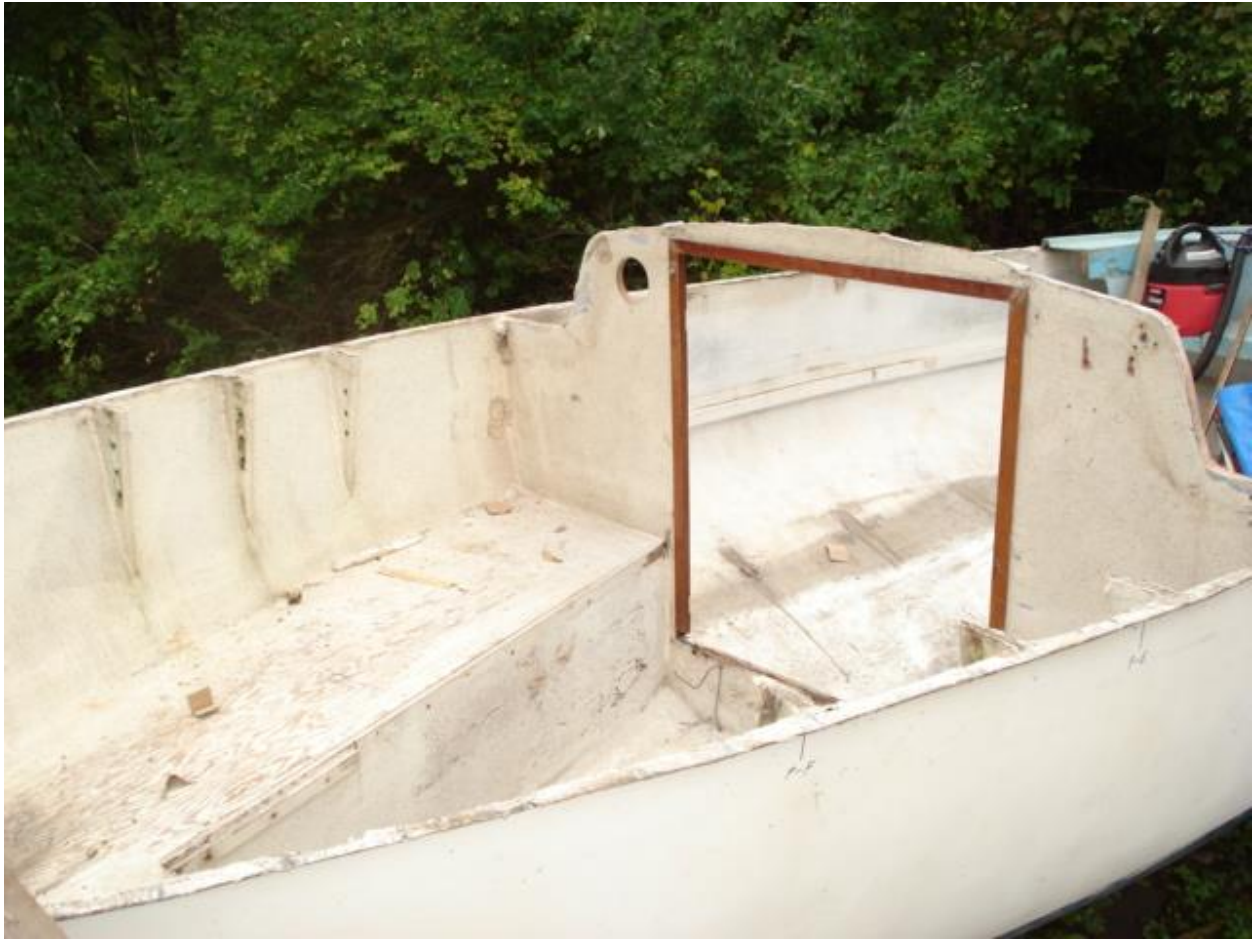
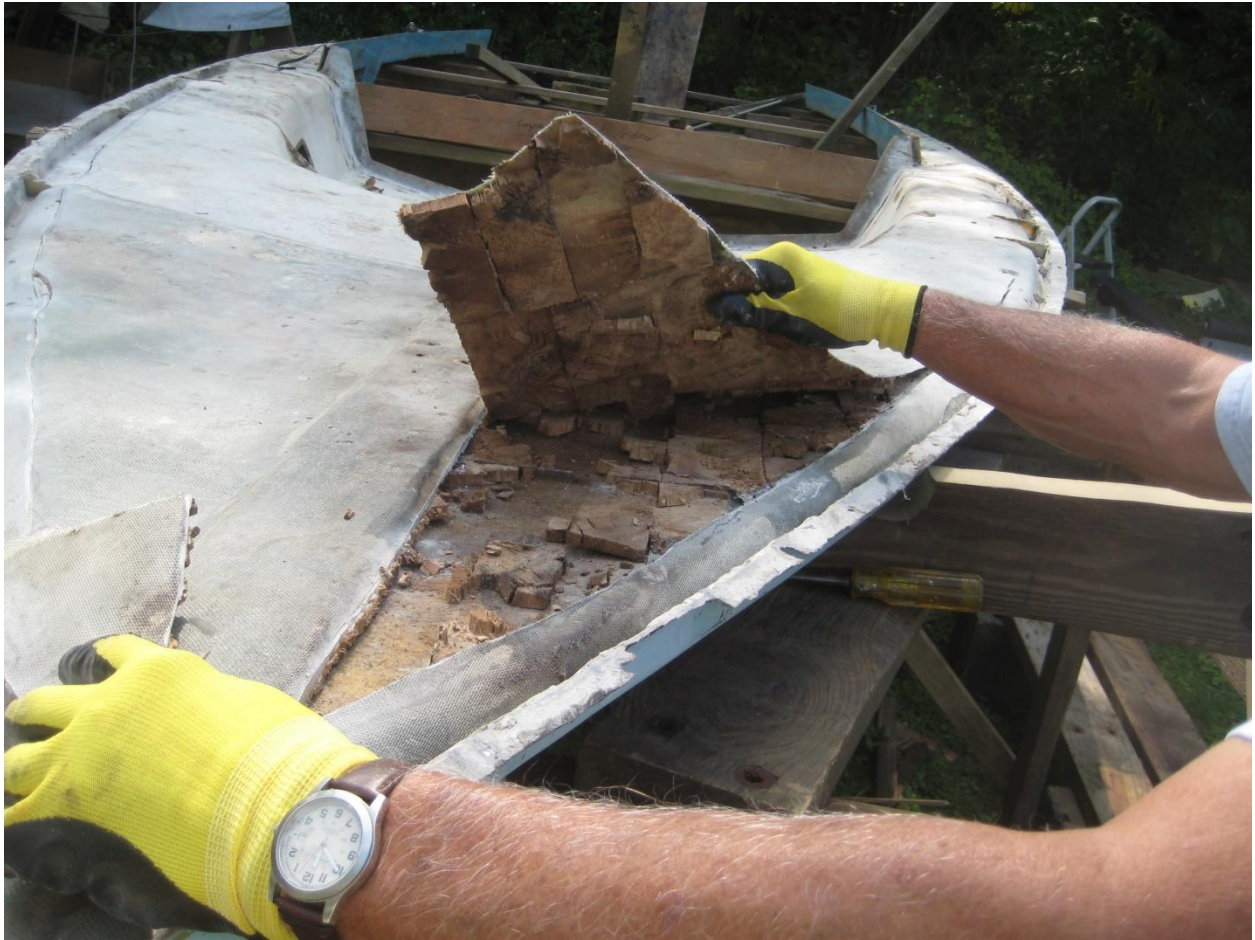
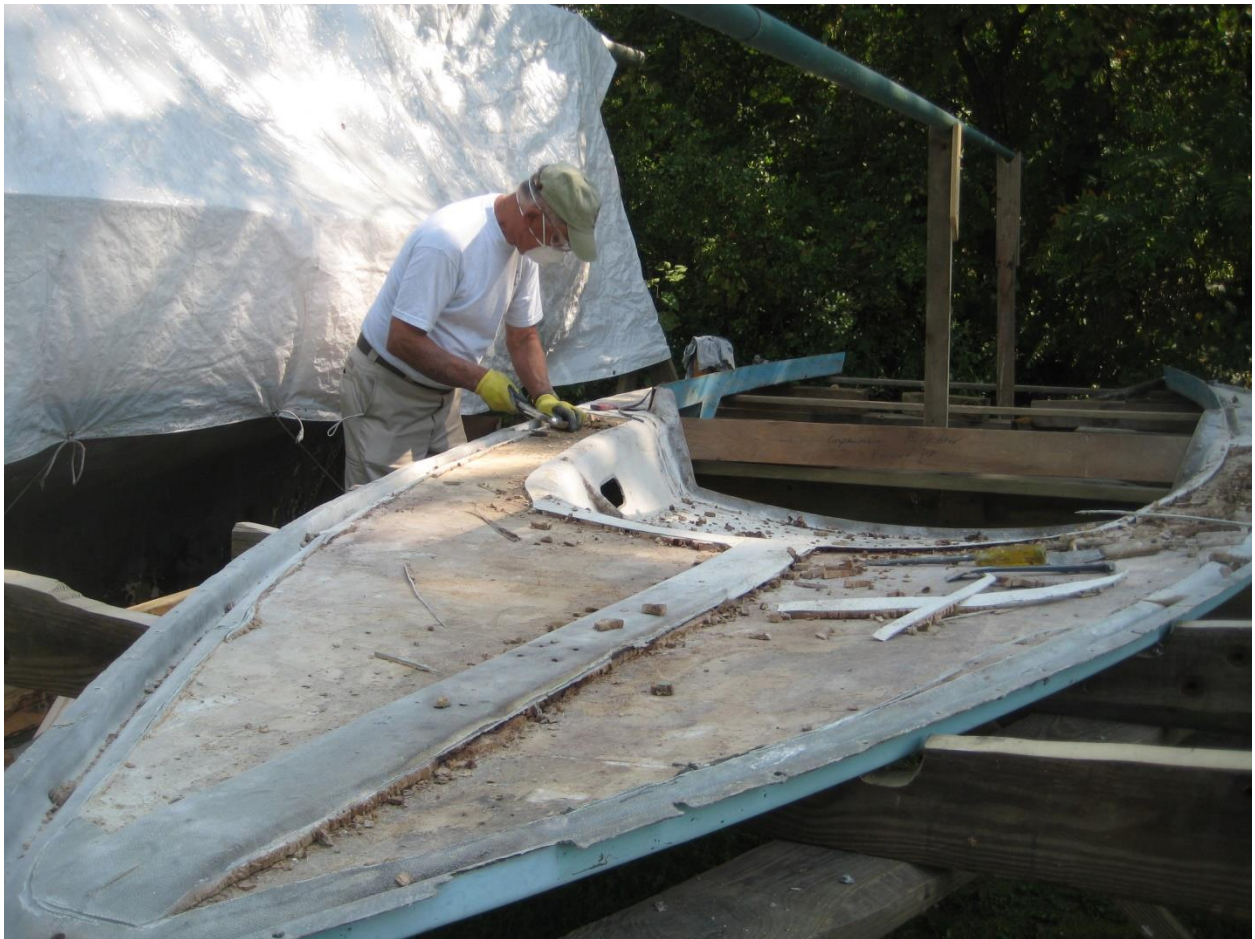
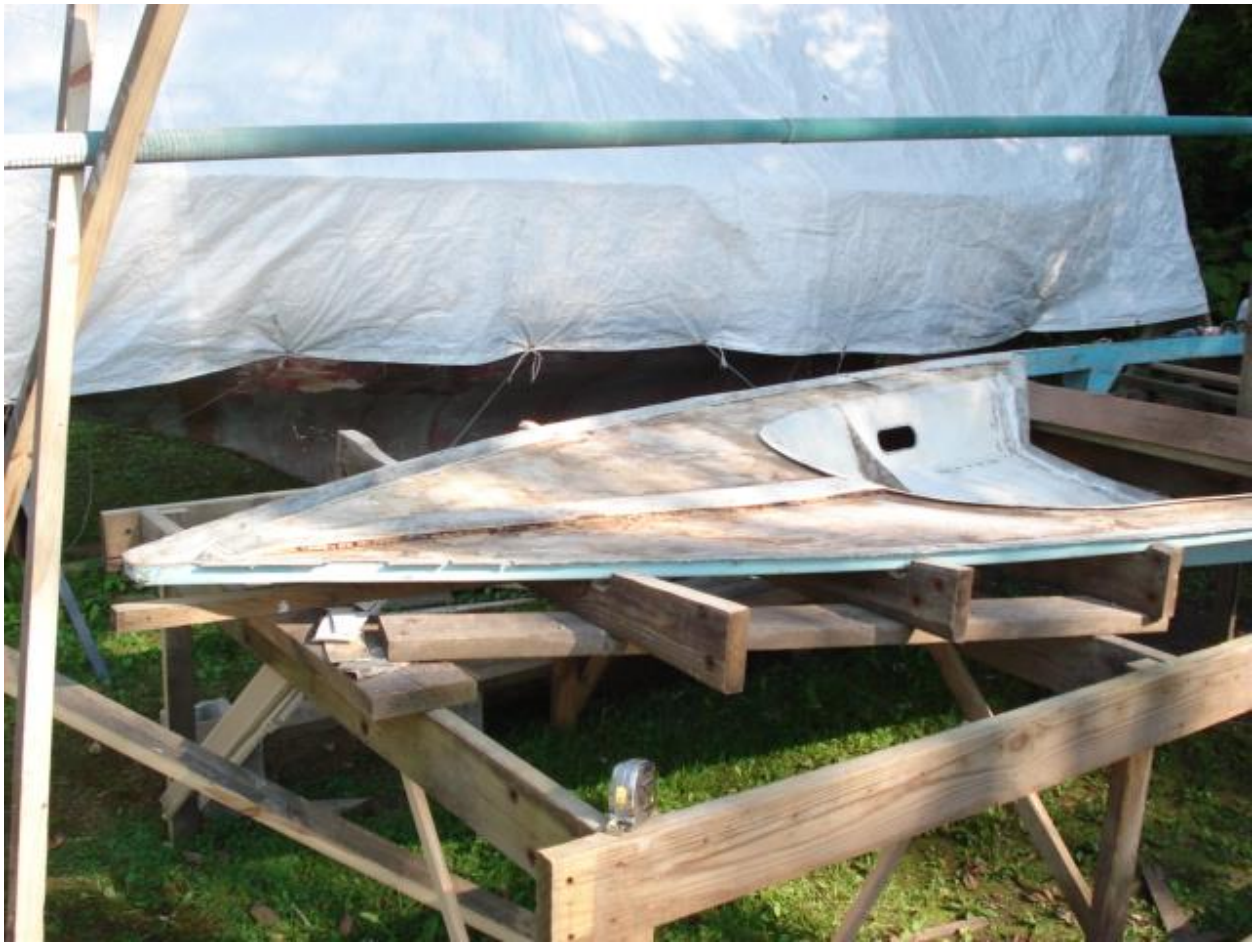
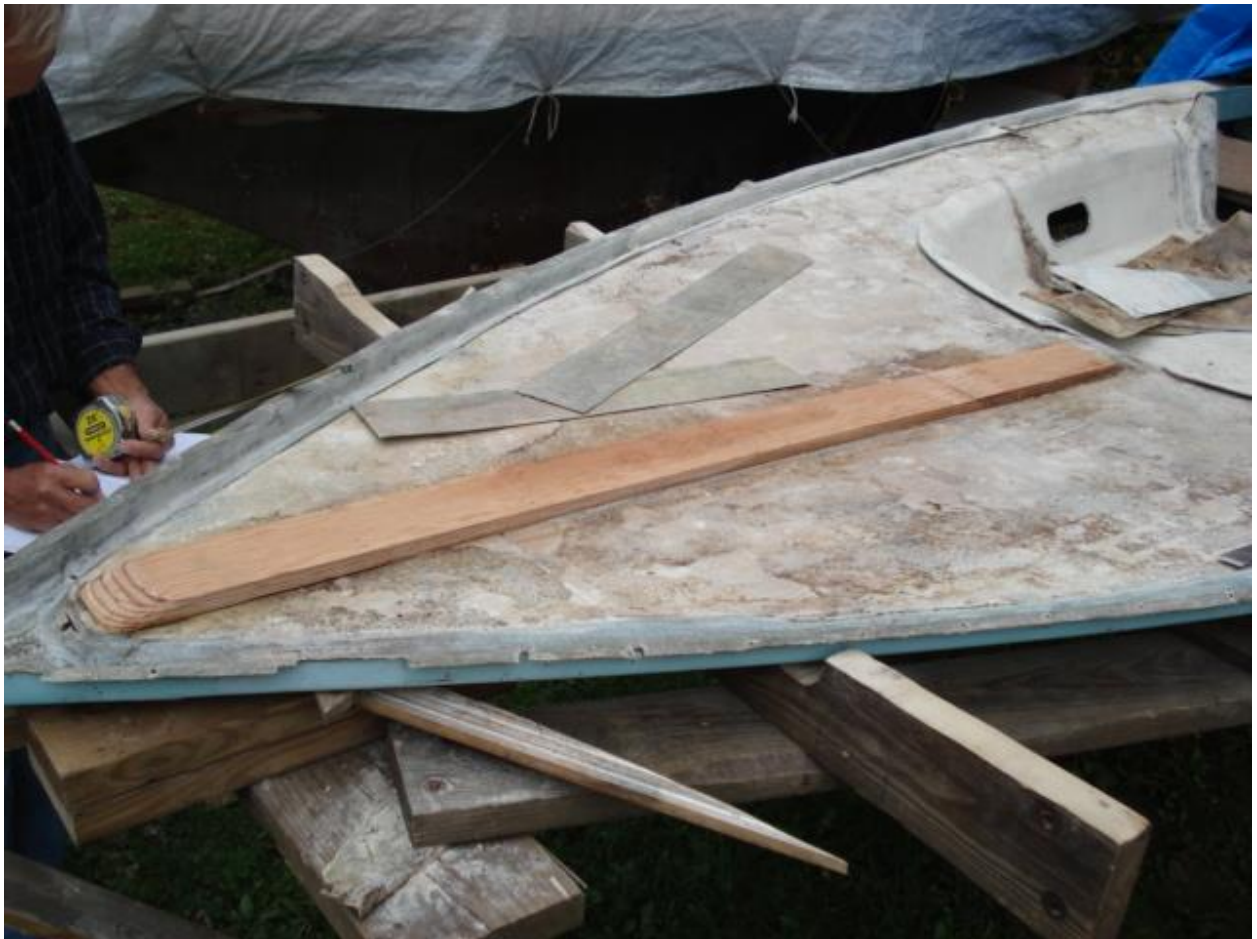
With the stern deck experience under our belt, we turned our attention to the larger foredeck/cabin top unit.

The only practical way for us to undertake such a complete restoration was to separate the deck from the hull so that the underside of the deck and cabin top surfaces were completely exposed. These sections were placed on a contoured work frame to preserve the original deck contours during the recore process. The underside of the fiberglass sandwich was cut away and the entire balsa core was removed. Closed cell foam was installed to replace the balsa, and a new layer of fiberglass was laid up to complete the new sandwich. This process enabled us to maintain the integrity of all the original deck and cabin top outer fiberglass surfaces. In addition, with the hull wide open, we were able to examine areas of the Ensign not normally accessible with a localized repair. Corrective action, such as the replacement of the king plank and the cabin top ribs, was taken where needed. With the re-coring

completed the decks and cabin top sections were reattached to the hull. 3M 5200 Adhesive was liberally applied to the flanges prior to rivet placement.

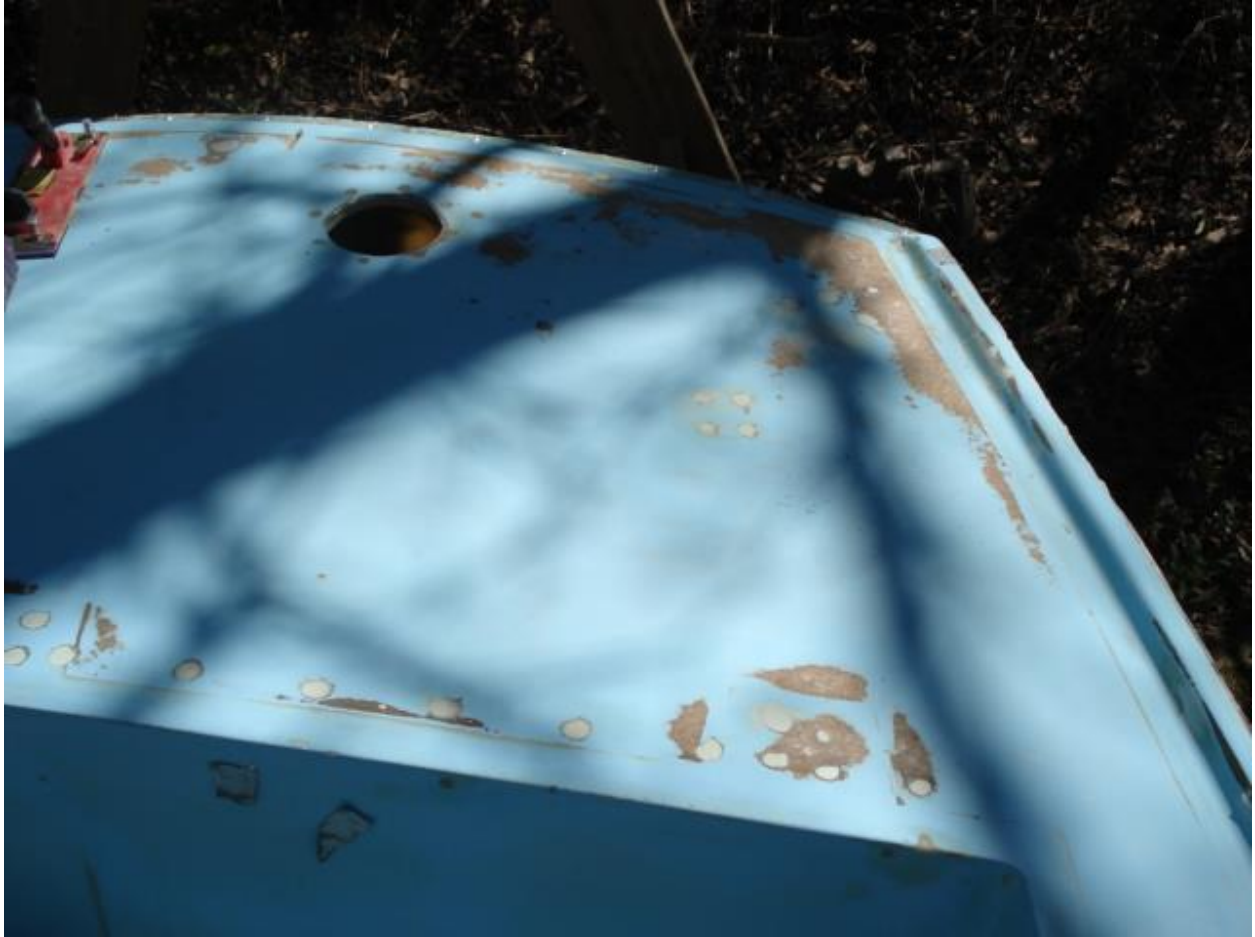
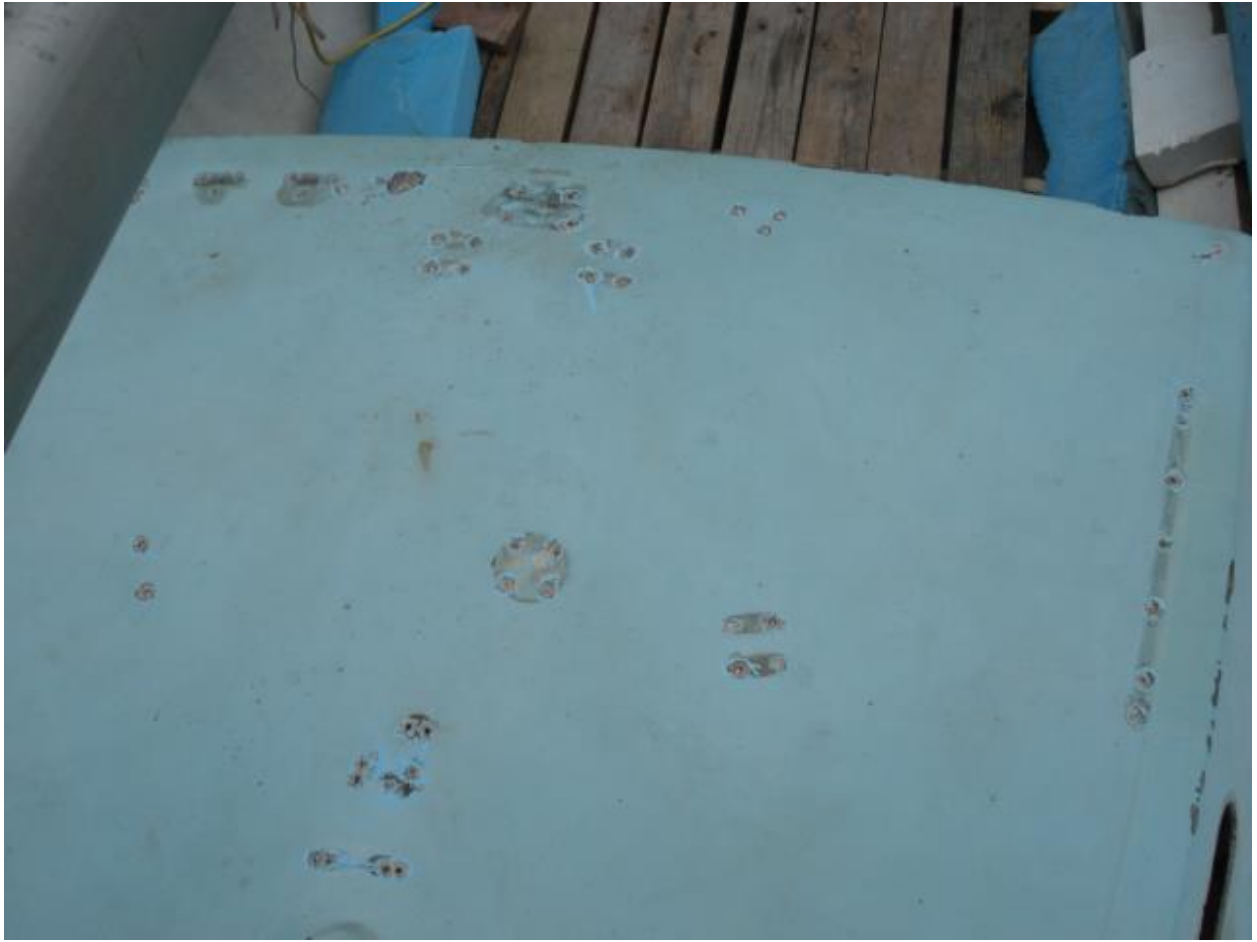
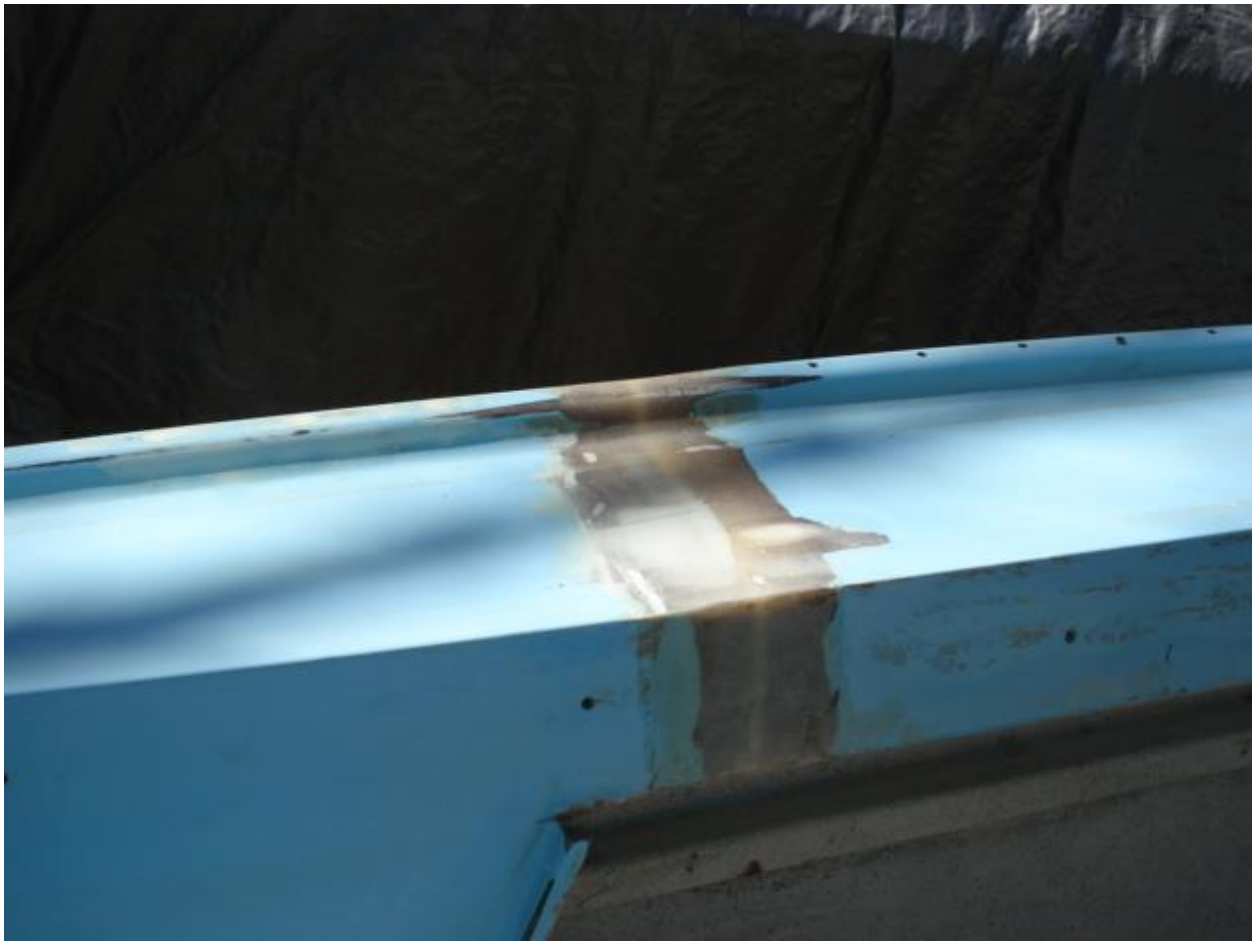
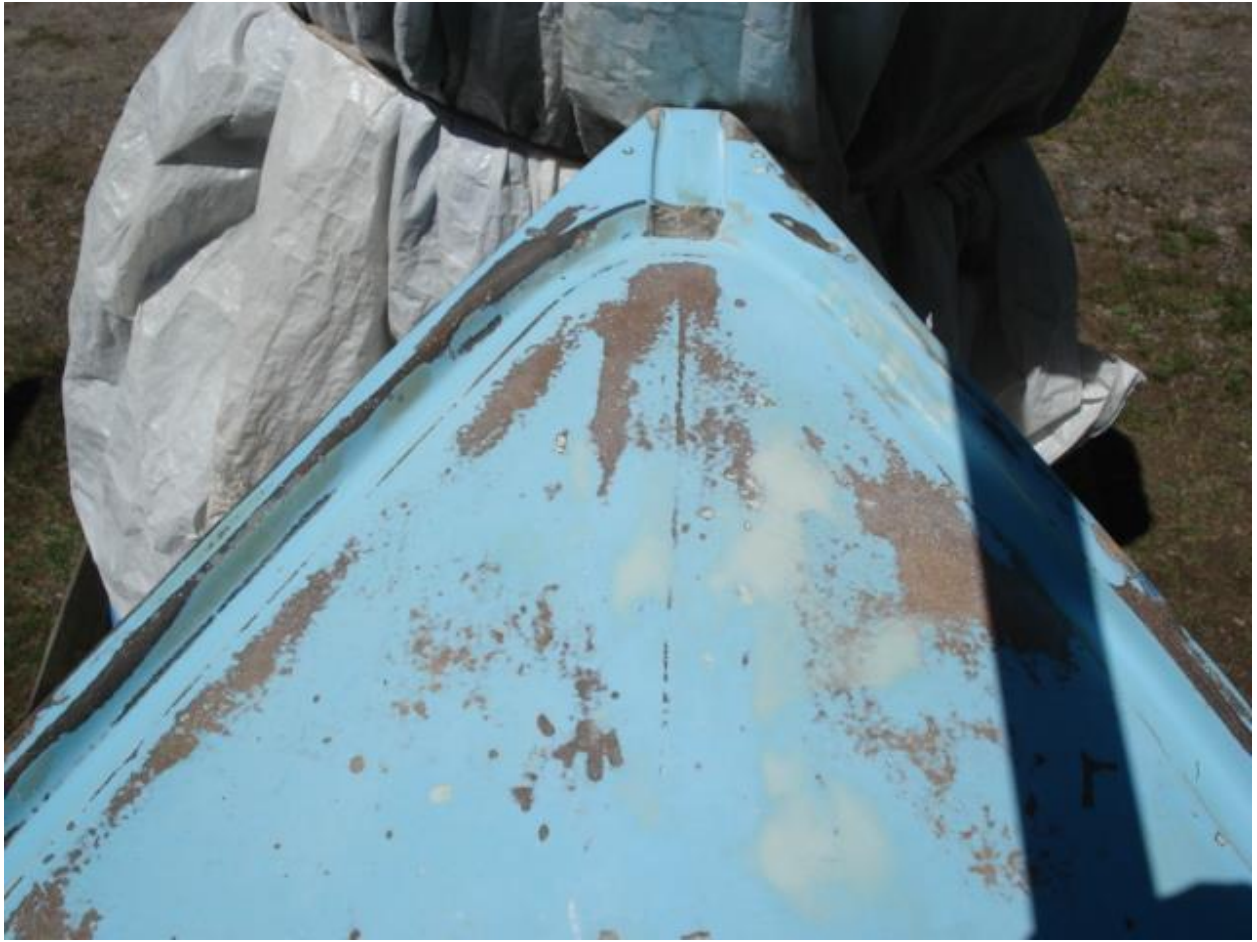
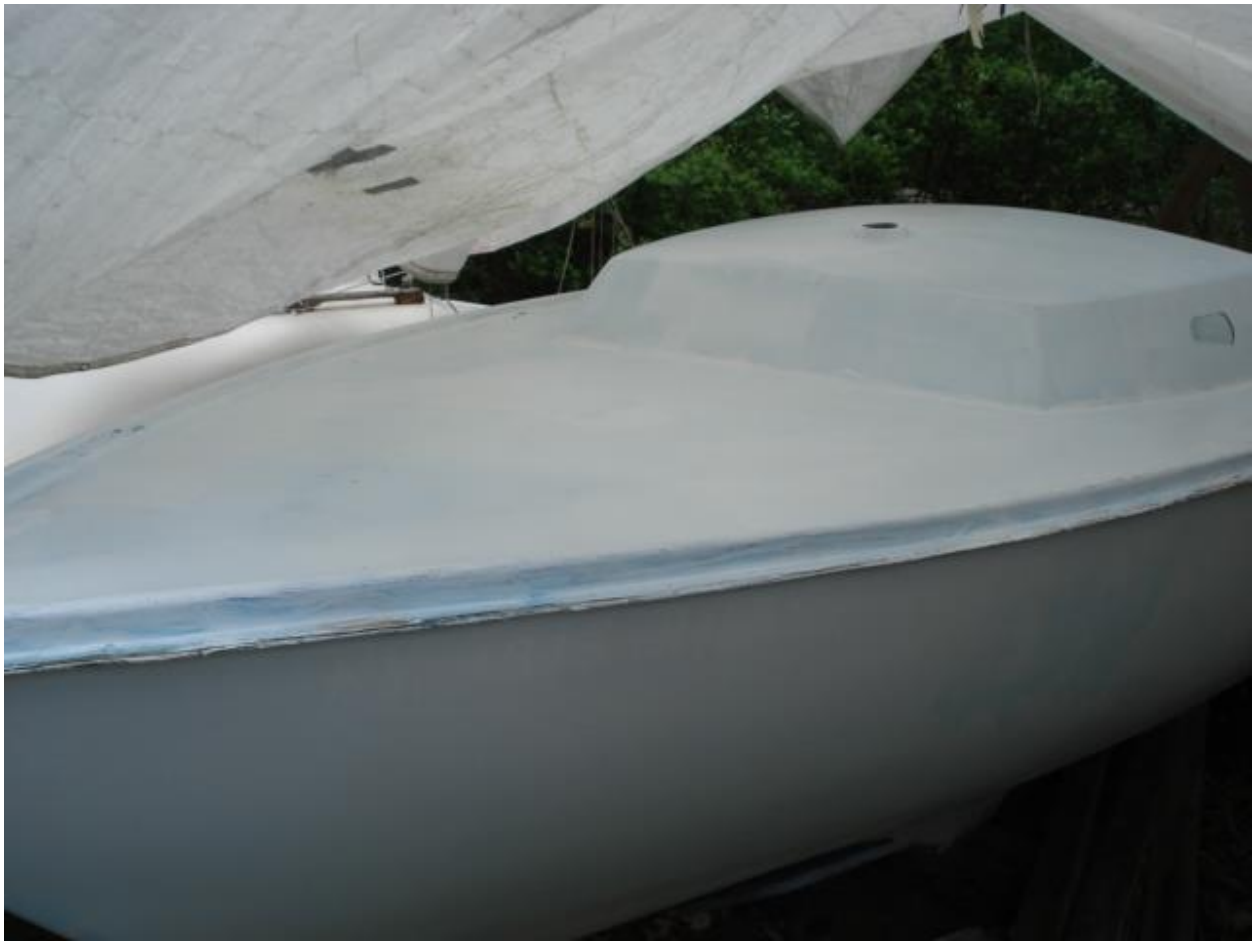
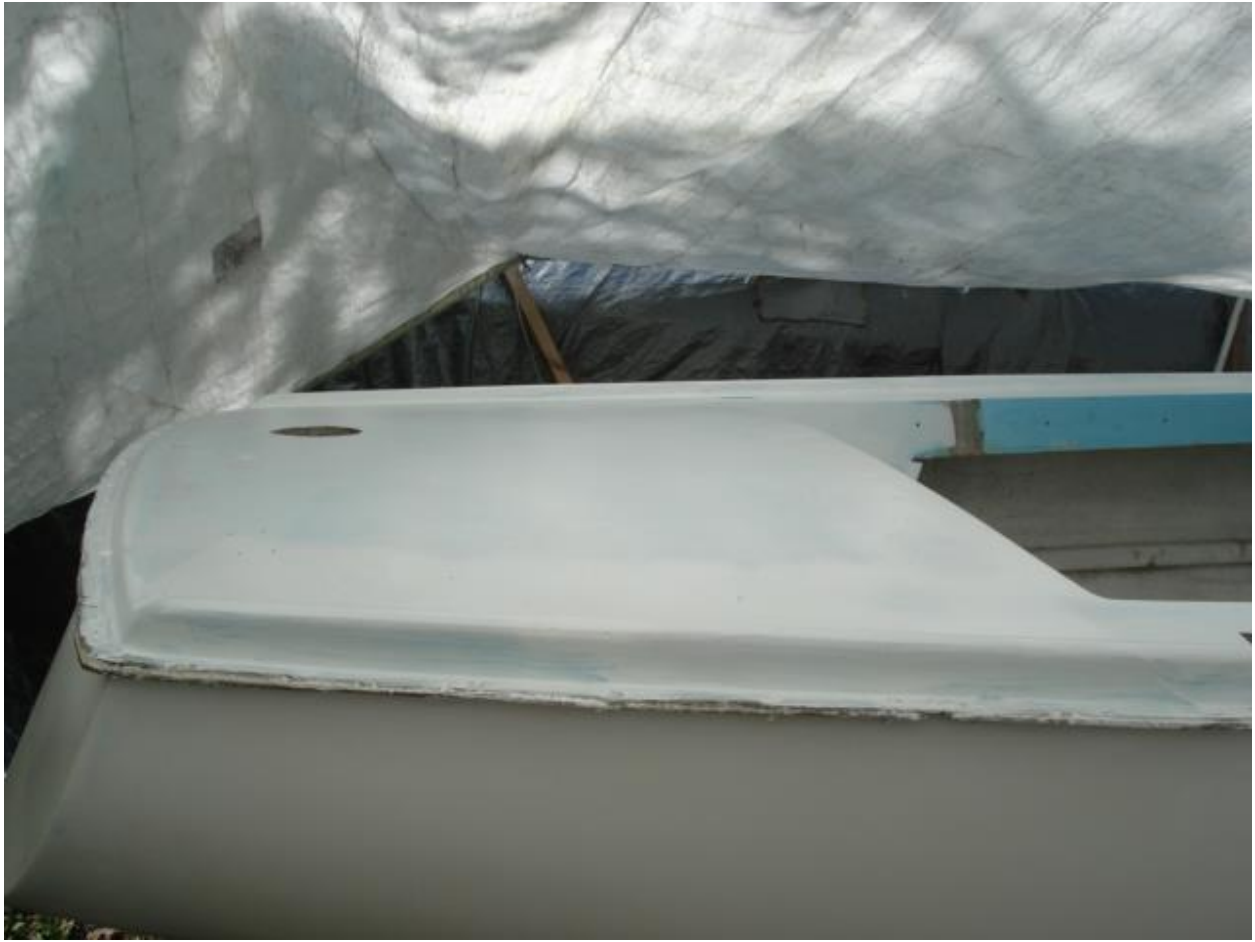
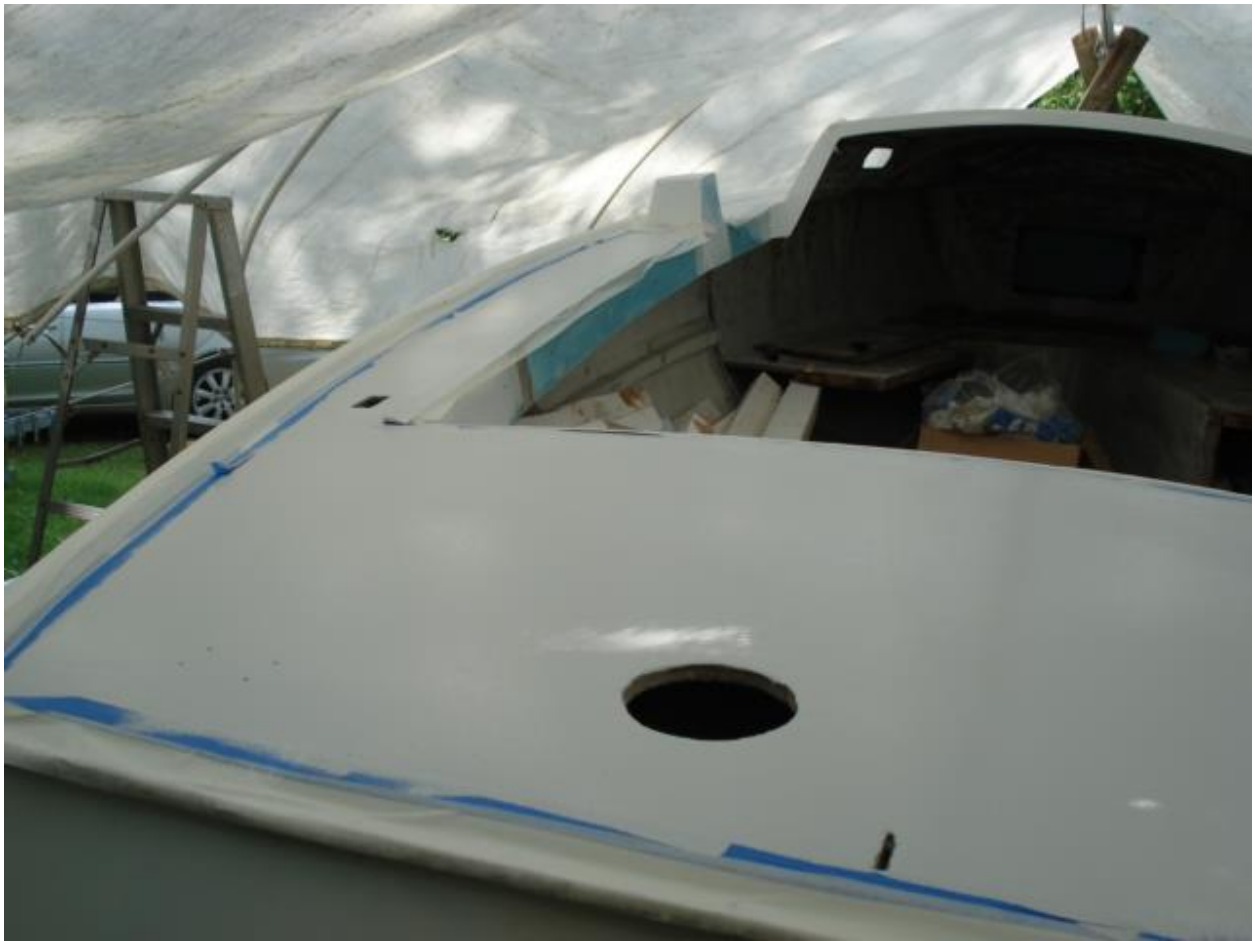
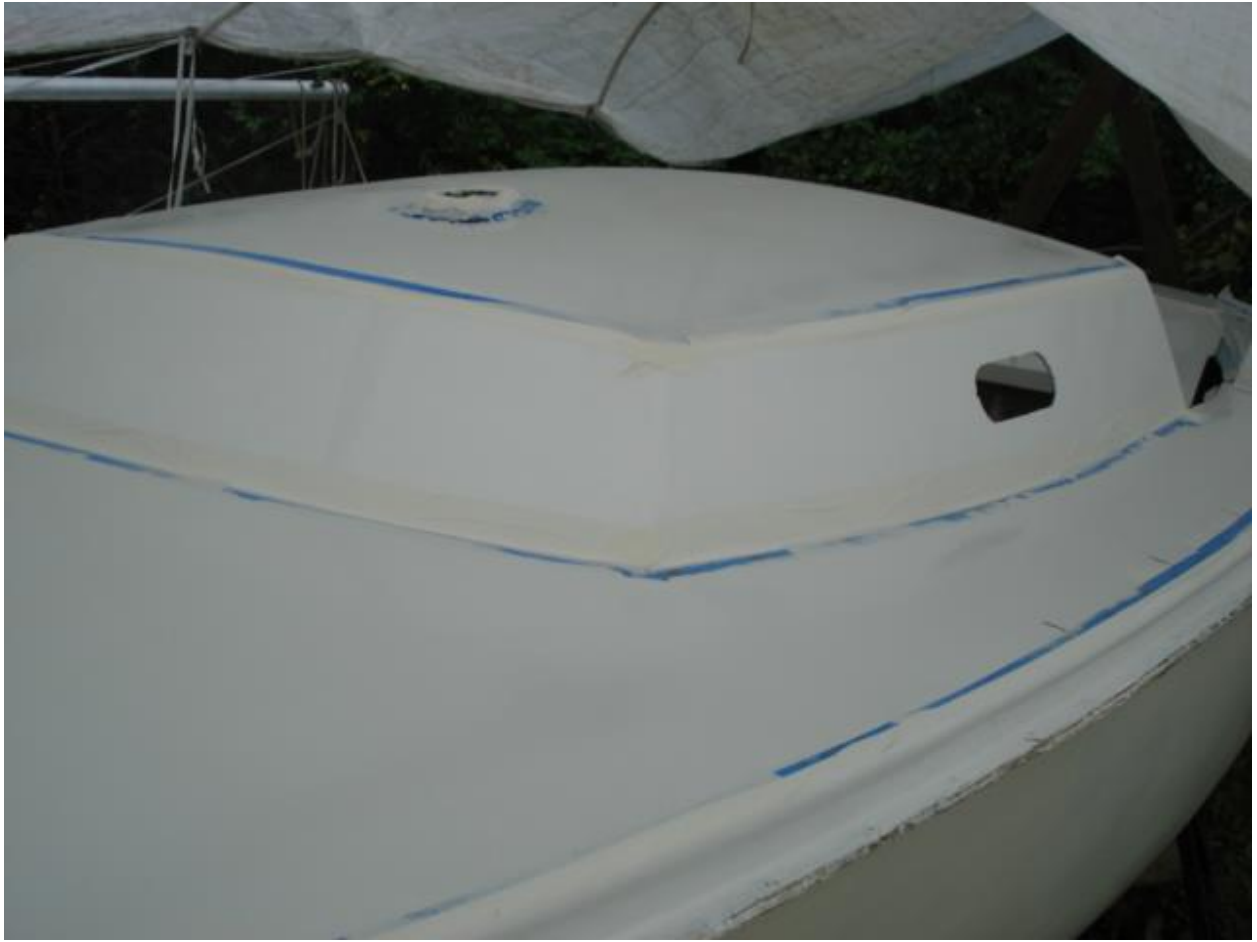
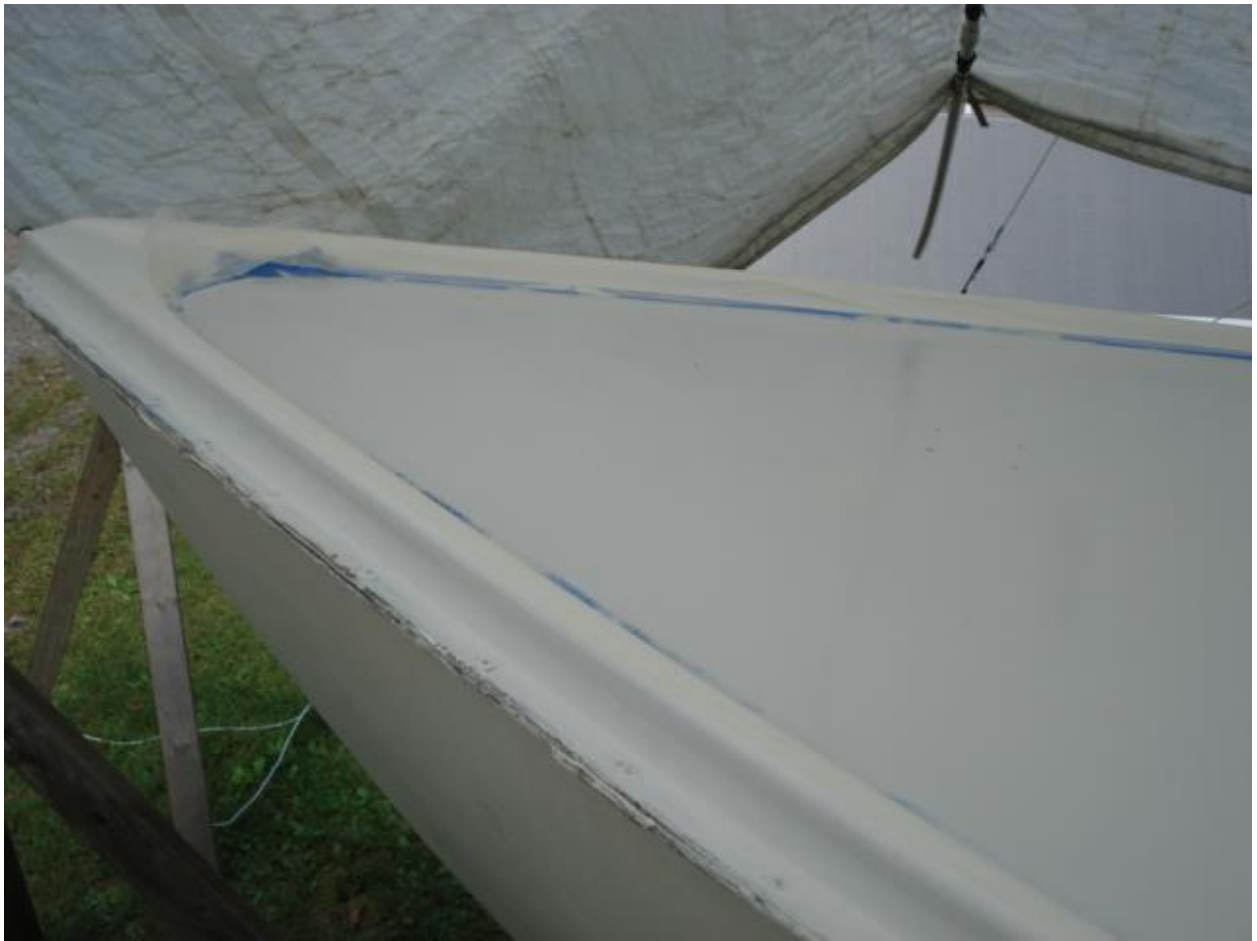
The recore process required that all hardware be removed from the deck surfaces, and this created a fresh canvas for new hardware and rigging decisions. However, it also created lots and lots of hardware holes and blemishes to be prepped, filled, faired, primed, and painted. We chose to use 2 part polyurethane Perfection and epoxy primer for the deck surfaces, and Intergrip non-skid additive for the non-skid areas. Project rule of thumb: 85% of a painting project is preparation.
